*March 26, 2014*

# SHARON HIGH SCHOOL

181 Pond Street | Sharon, Massachusetts

*Executive Report - 2013 High School Conditions Study*

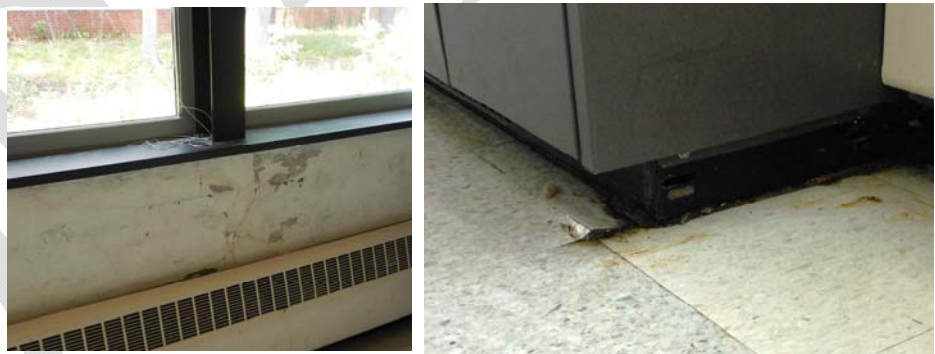
Water damage shown on the interior of the building

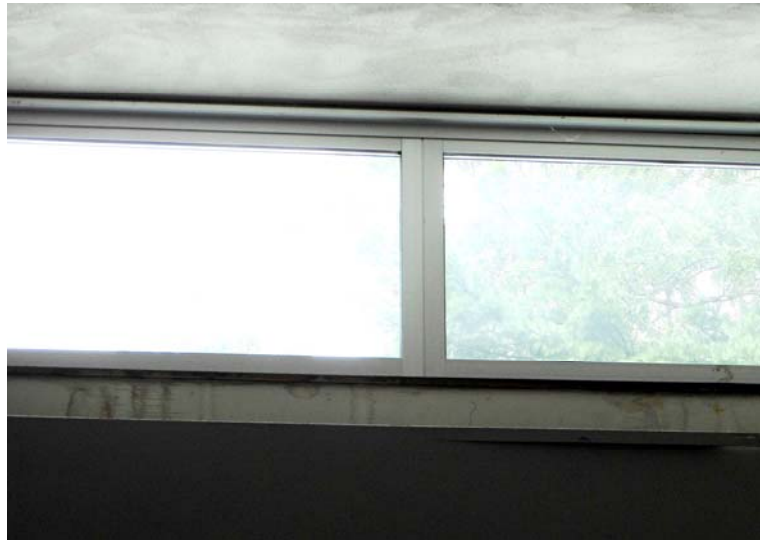
Water damage at interior wall at clerestory windows above auditorium lobby

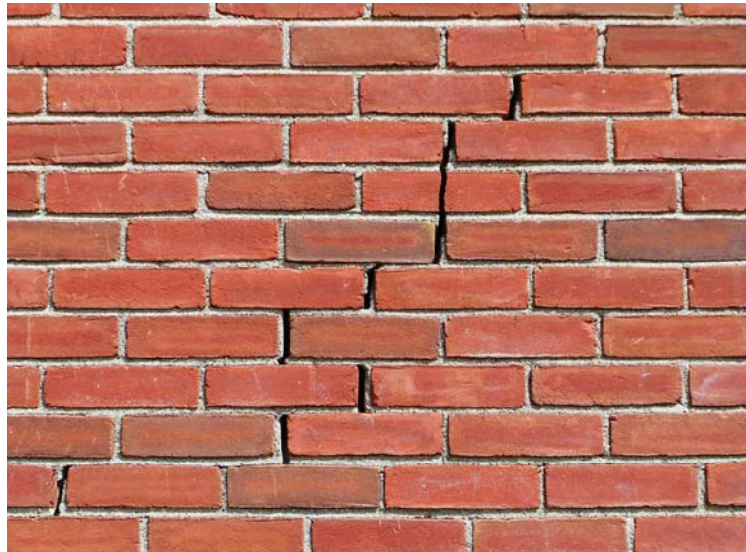
*Brick settlement cracks at south wall of original building*

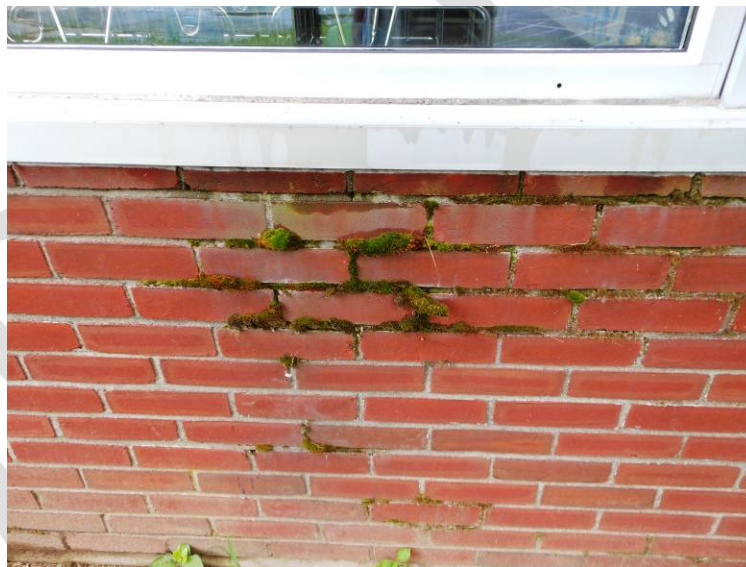
*Moss growth on the exterior walls*

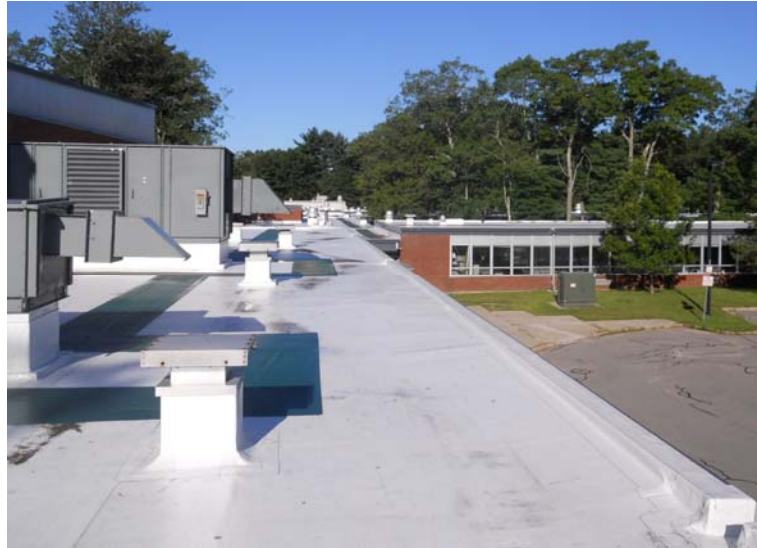
roofing system was indicated in the 2011 report to be in fair condition and that it had several years remaining under warranty.

2011 roof replacement

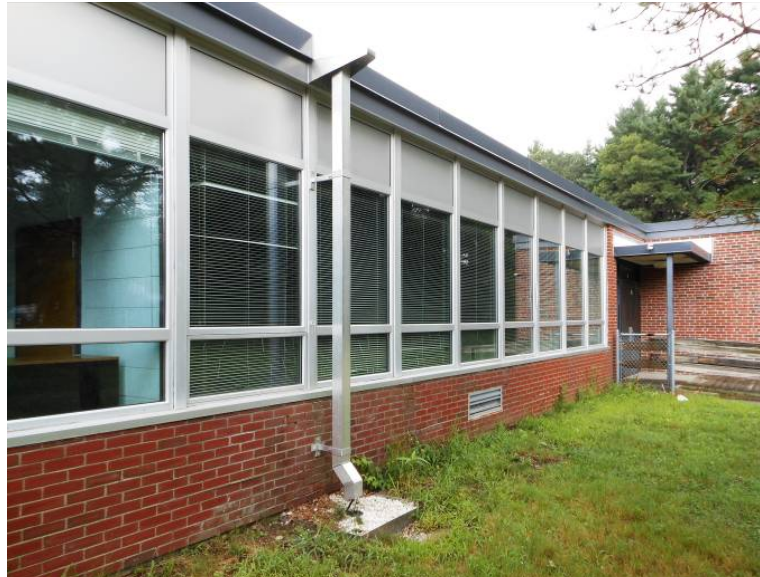
*Typical scupper with stone splash pad*

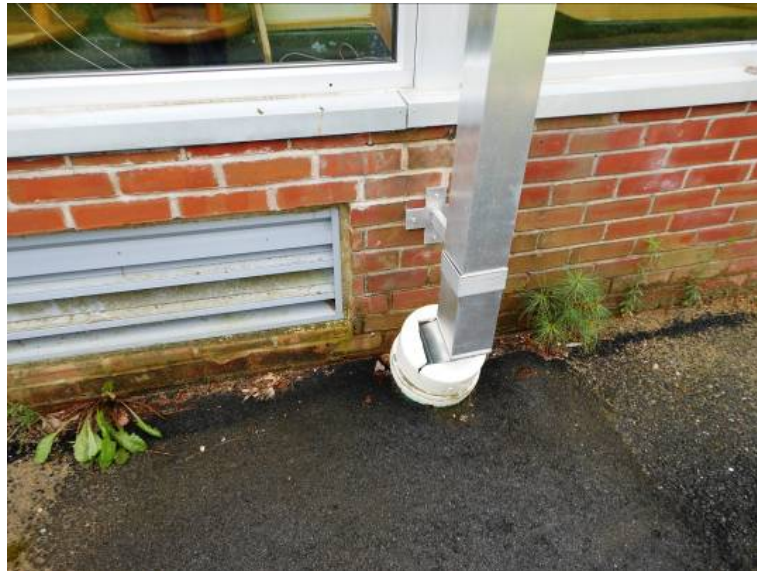
*Scupper base at asphalt condition*

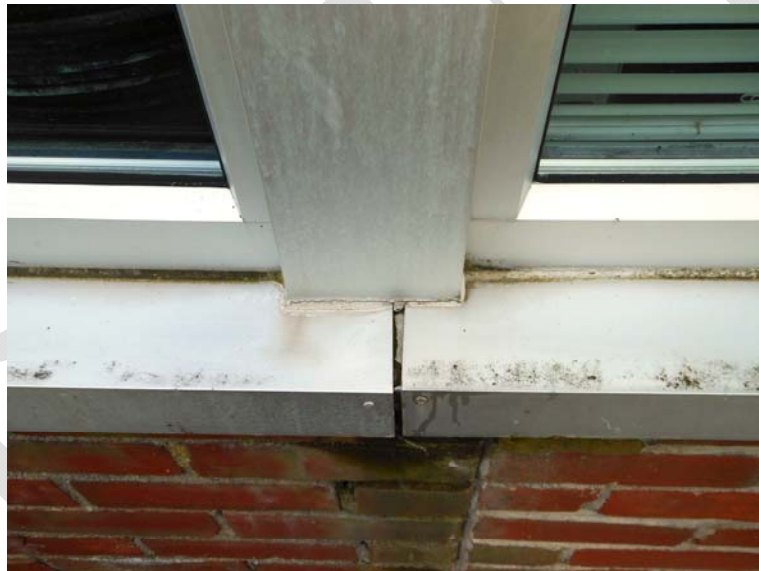
*Storefront sill overlaps create water damage to wall below*

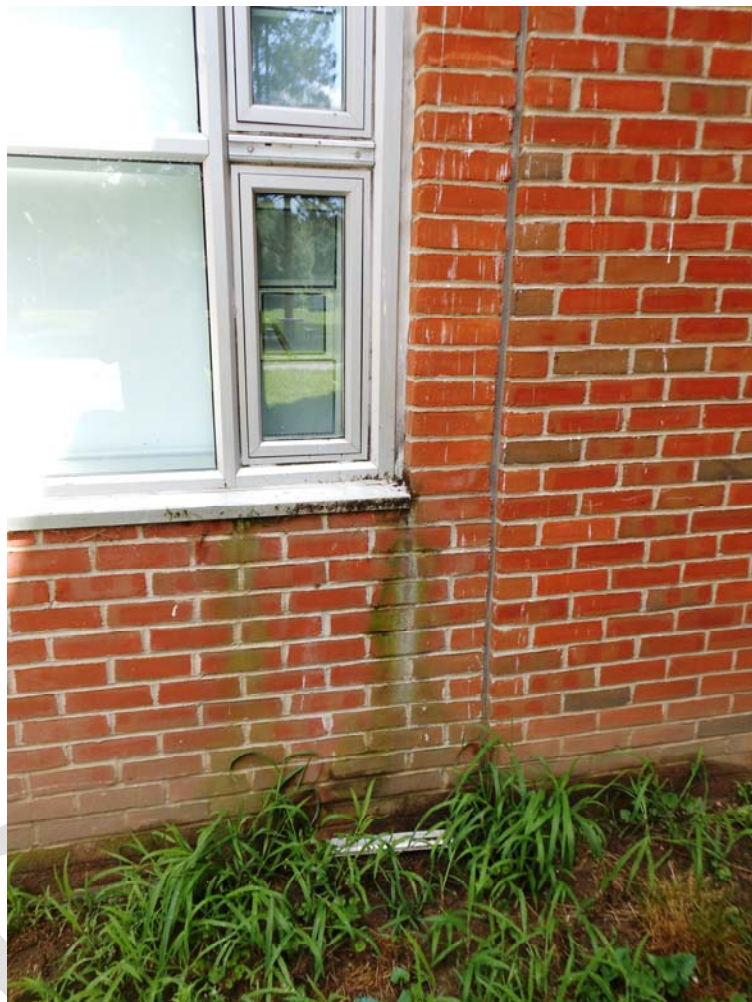
Moisture damage to wall because of storefront caulking and overlaps  
Efflorescence on the exterior wall and snap-on mullion removed and sitting on the ground

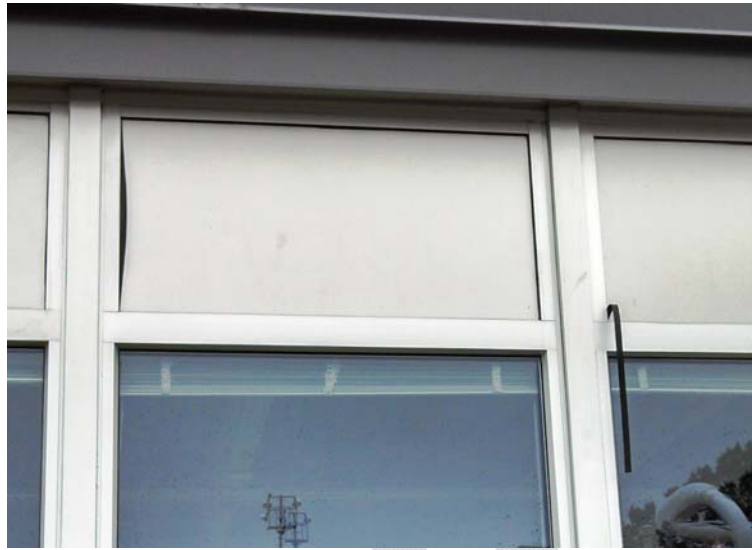
Missing and loose gasketing at storefront infill panels

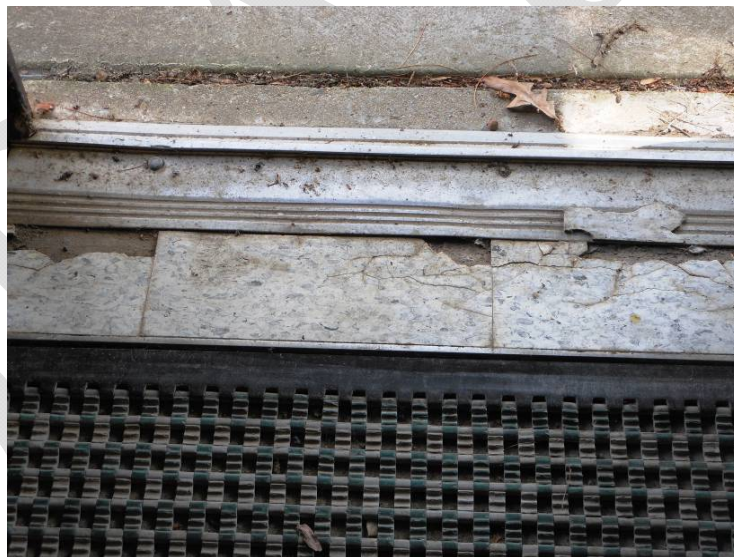
*Exterior door showing damaged floor tiles and threshold*

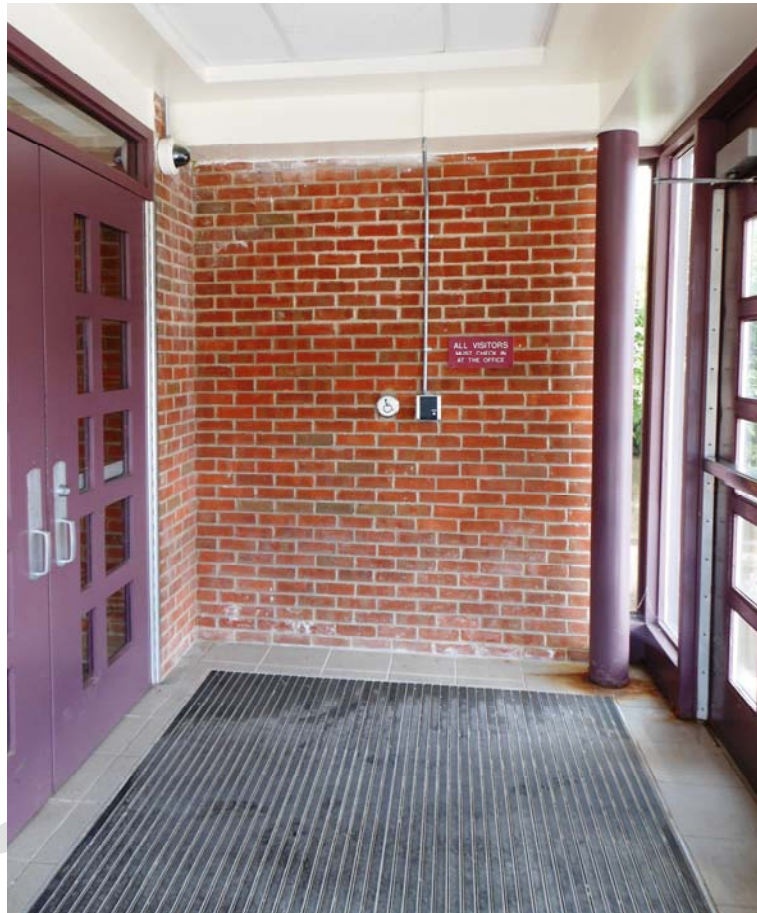
Automatic door opener and security at main entry doors

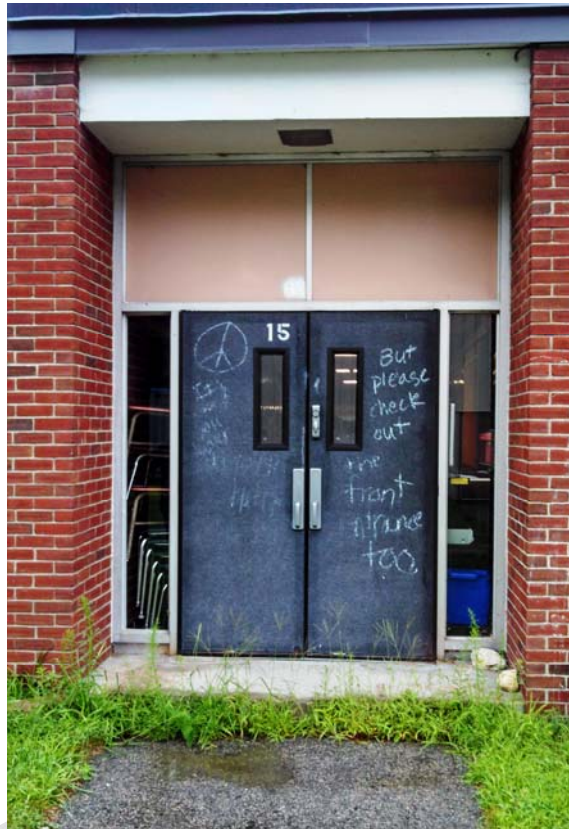
Typical exterior door showing step down, overgrowth, and damage

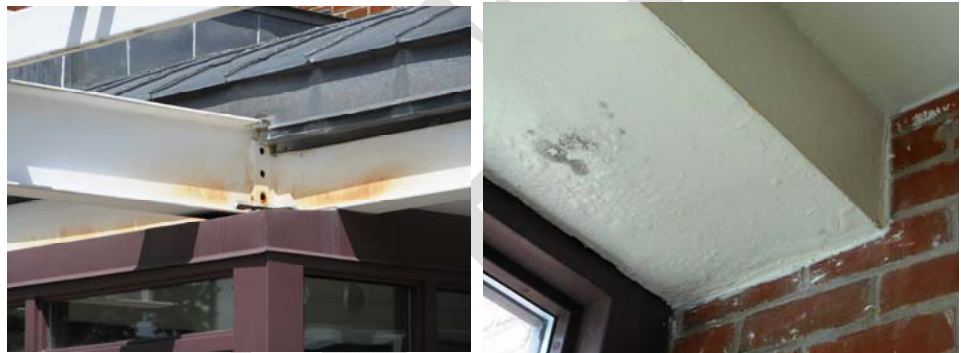
At the main entry, mold and mildew on the exterior show evidence of water infiltration from the exterior canopy above. There are many other locations where the soffits are deteriorating. There are several locations with major cracks and water stains are evident.

Mildew and bubbling at main entry soffit vestibule.  
Rust damage on exterior shows water infiltration.

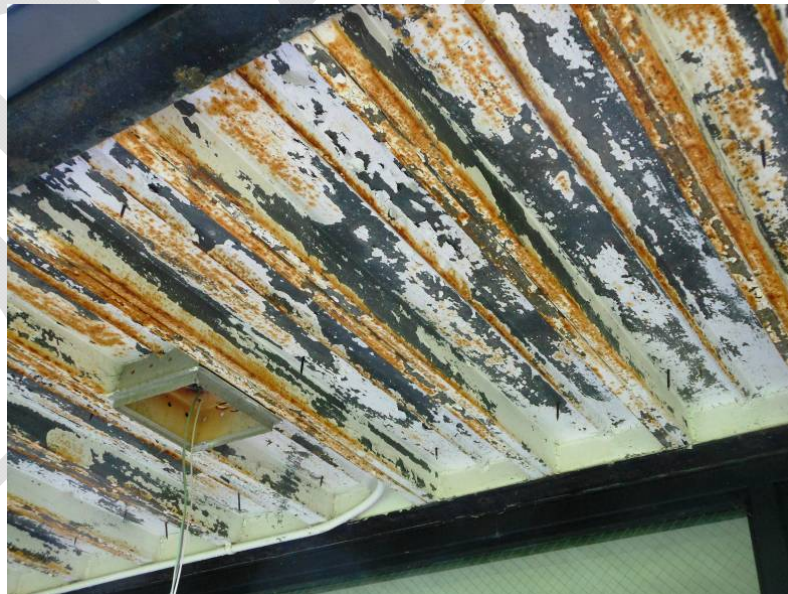
Exterior soffit with exposed metal deck and exposed abandoned wiring

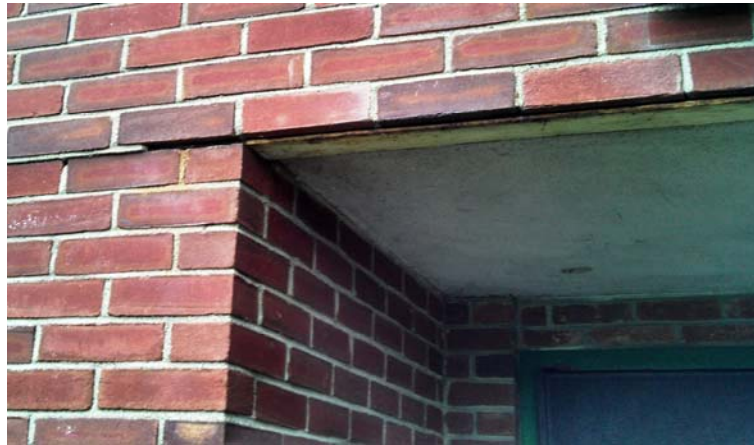
Locker room egress doors show damage to the lintel above and rust jacking has loosened the bricks

*Rust jacking at the exposed steel lintel*

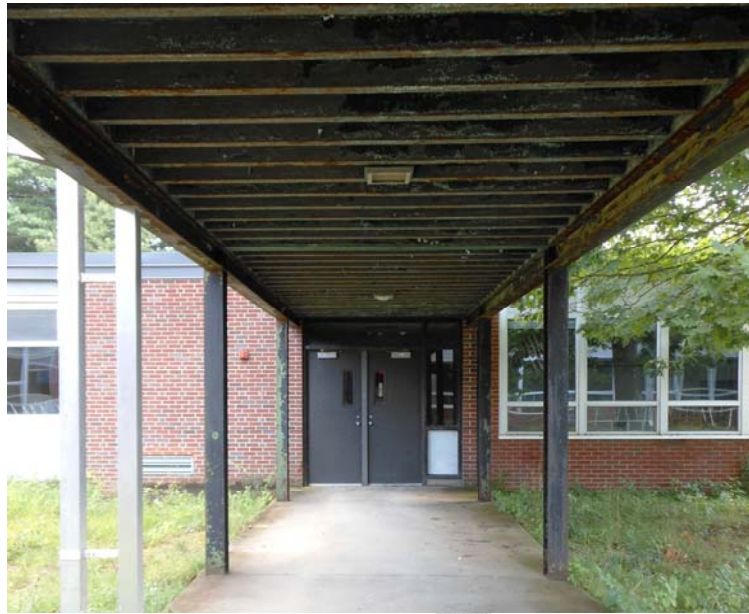
There are three courtyards located within the building. Much of the natural landscape has been overgrown due to the lack of access for any landscape maintenance equipment. The northern two courtyards are bisected by outdoor covered walkways however the paint and structure of these is in very poor condition. The doors to the walkways remain locked during most of the school year because of security concerns. The soffits show exposed structure which has chipping and peeling paint. Additionally, the columns and deck show extensive rust damage.

*Northern courtyard breezeways with rusted structure*

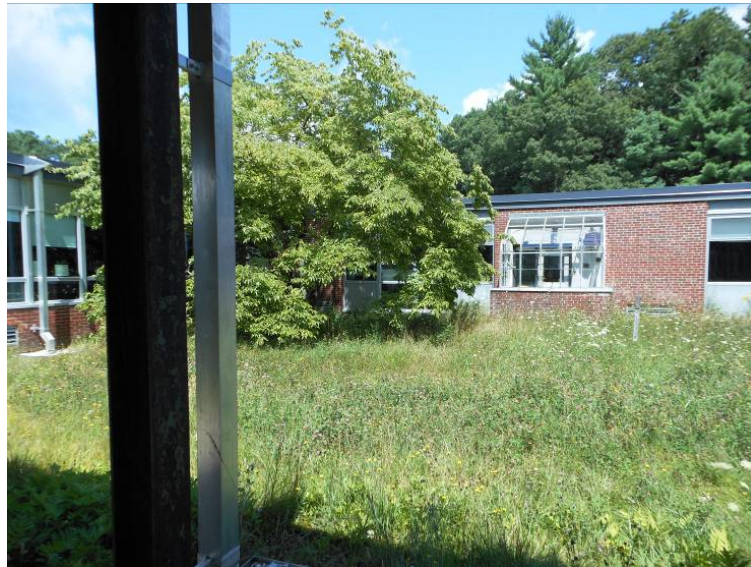
*Northwest courtyard with greenhouse showing overgrown condition*

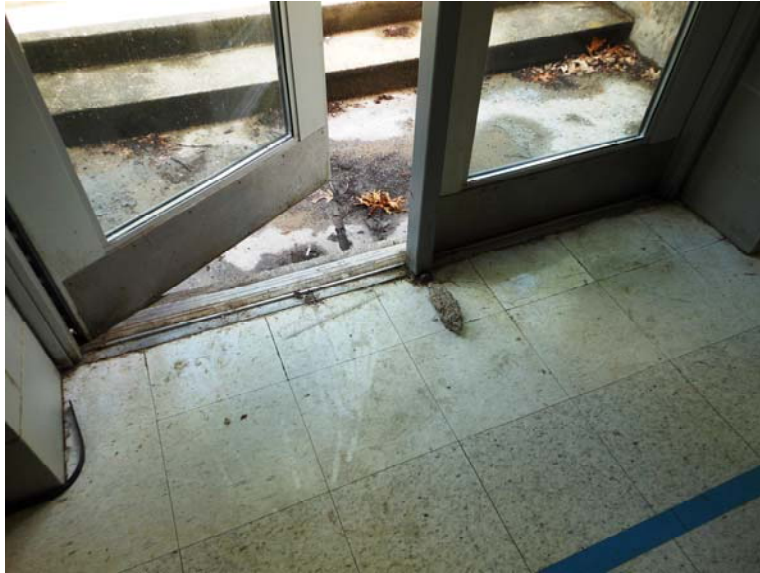
The northwest has access from the south by a double door to the corridor. Grade at the south wall is higher than the adjacent floor. Water enters the corridor from a depressed slab at the door to this courtyard and has damaged the threshold and tiles at this location.

*Northwest corridor water infiltration concern area*

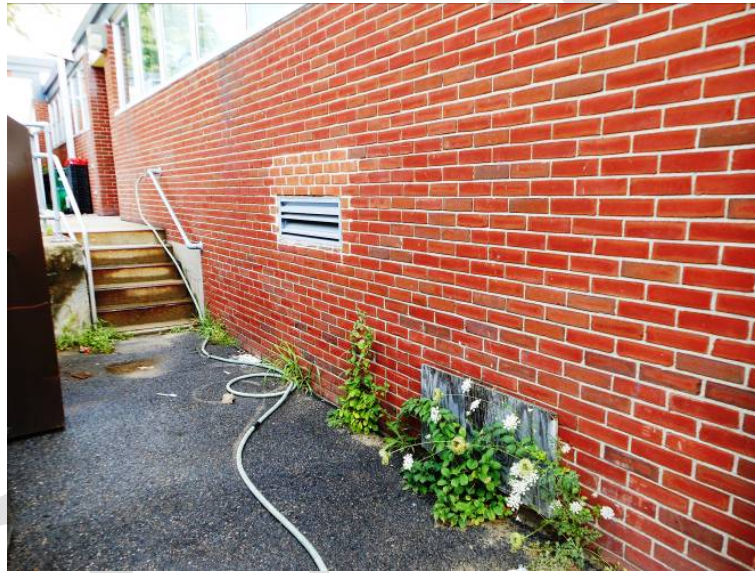
Over time as changes were required, brick infill has been added to patch holes in the masonry and not only does it not match the surrounding brick, but in many cases has been filled with grout. Other infill areas have been covered by plywood which is rotting and loose which can potentially allow water and insects to enter the building.

*Loading dock stairs and infill plywood panel*

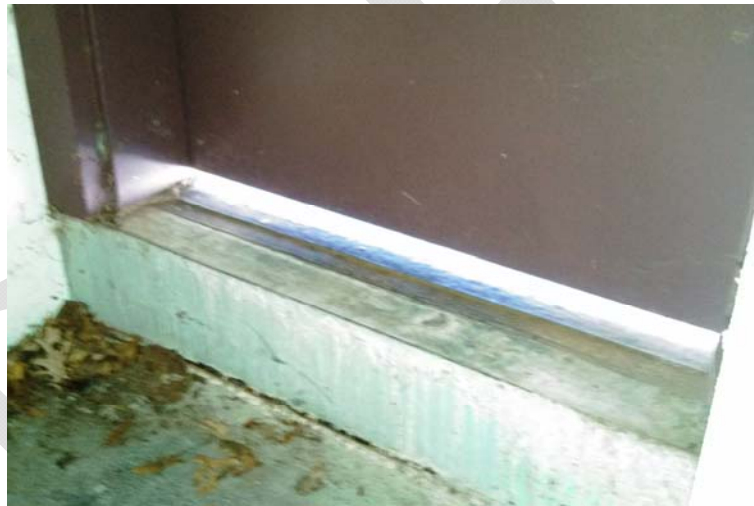
A large gap at the bottom of the door to the roof and a lack of threshold allows water to enter into the egress stair. Although the GWB has been replaced, there is still evidence of water damage on the walls and from bubbling of rubber flooring.

Gap at base of roof access door for water infiltration

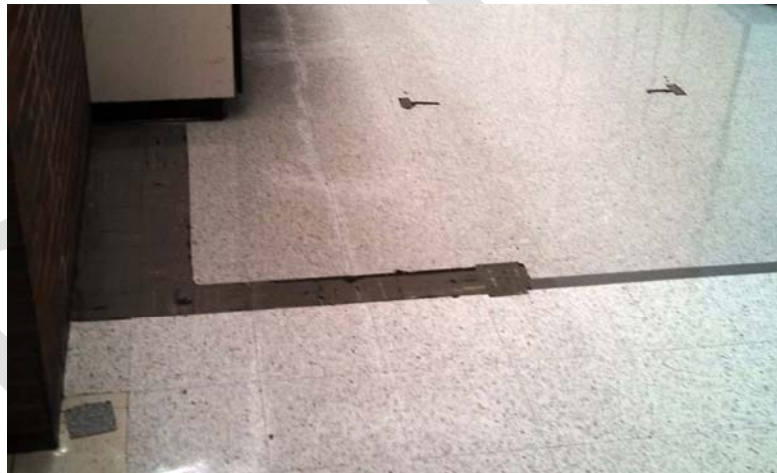
The flooring in the original building as well as the 1963 addition has not been updated and it is beyond its useful life. In the classrooms and corridors mismatched vinyl composition tile has been patched in where worn tiles were removed.

*Patched or mismatched tile infill*

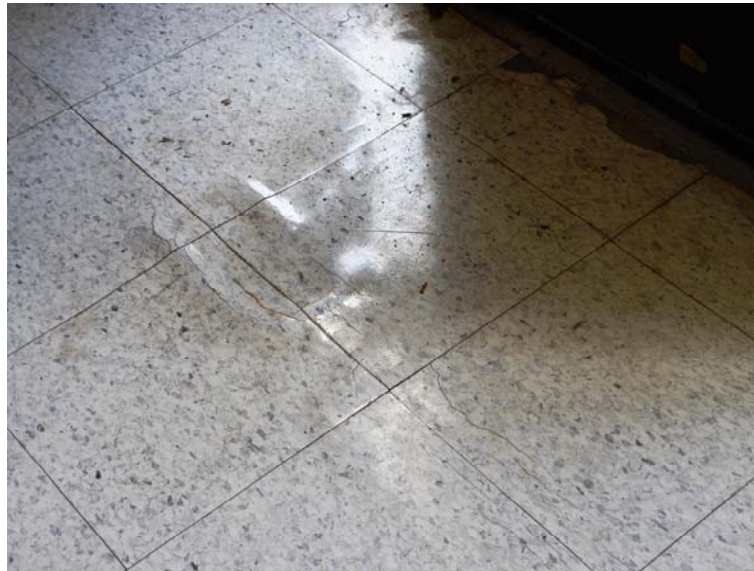
Additionally, there are many locations throughout the building where evidence of wear and water infiltration have damaged vinyl floor tiles that remain in place. As was previously mentioned, many of these cases are as the result of water infiltration. In other locations it is typical wear and damage as a result of age.

Damaged floor tile

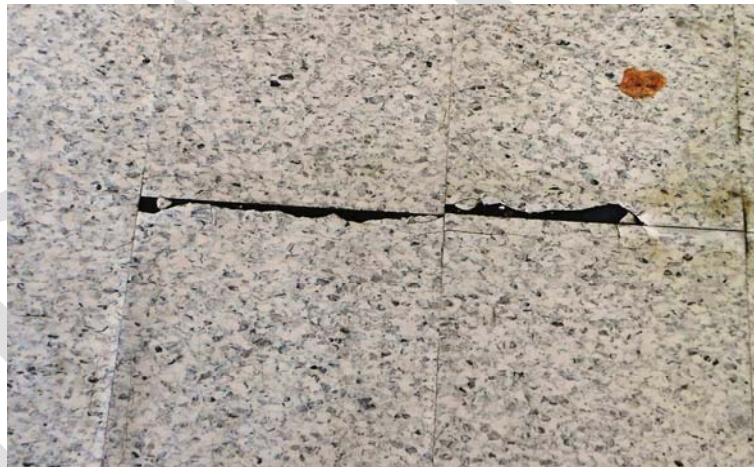
Damaged floor tile

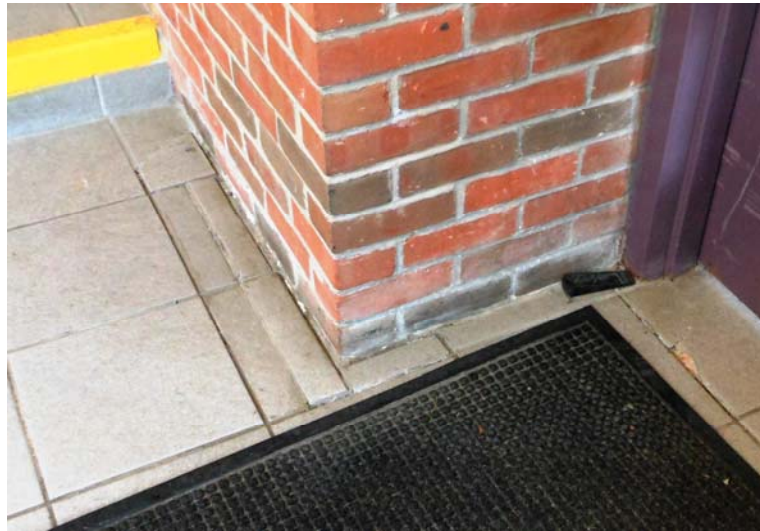
*Damaged floor tile in building lobby*

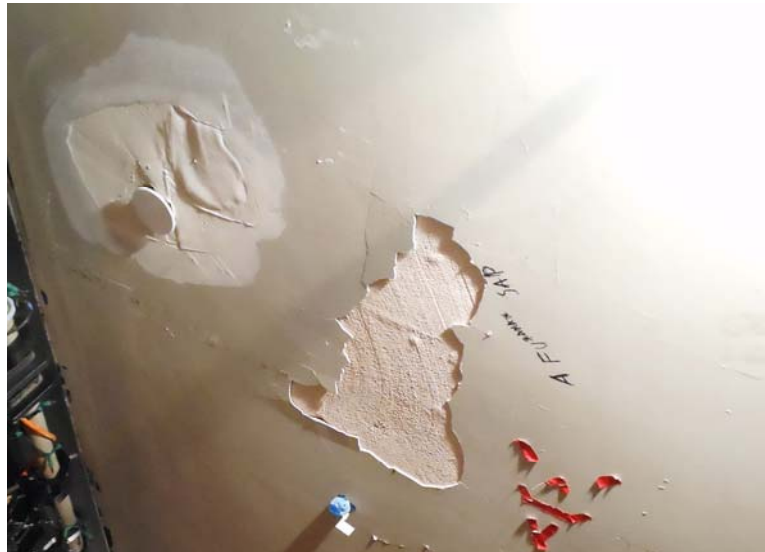
Damaged plaster ceiling in the auditorium projection room

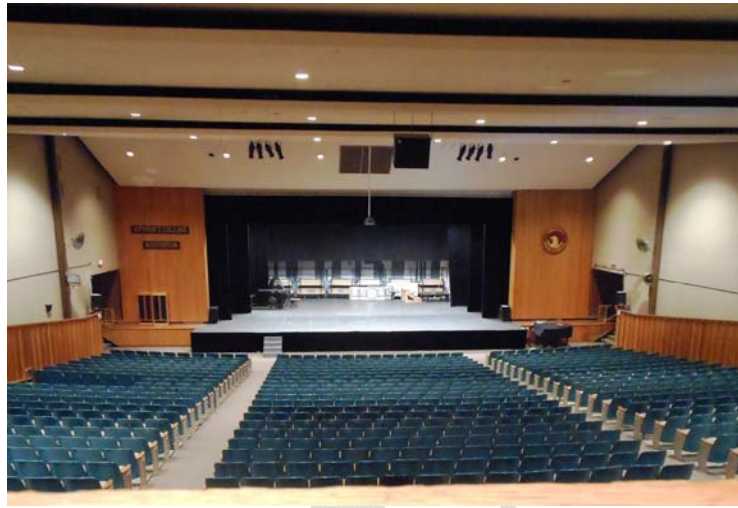
The stage is somewhat shallow and consequently, a temporary addition has been added to make the stage deeper. The stage does not include a fly loft or sufficient storage space for the required sets.

*View of stage in the auditorium*

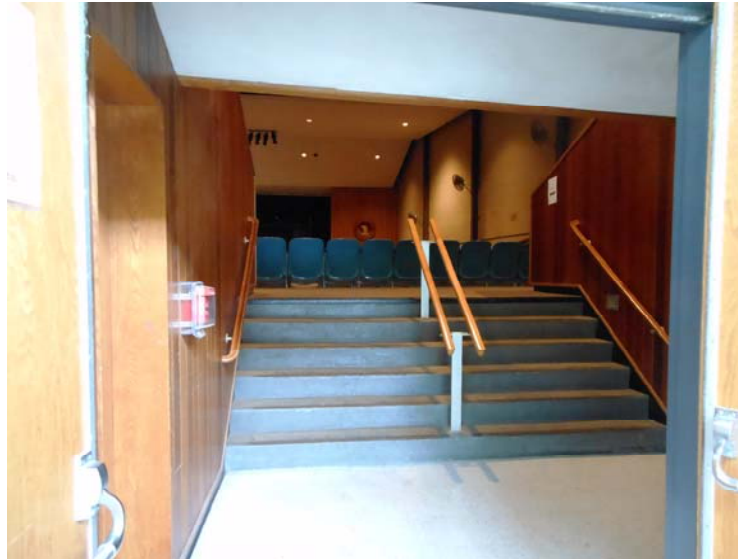
*Public entry into the auditorium is not accessible*

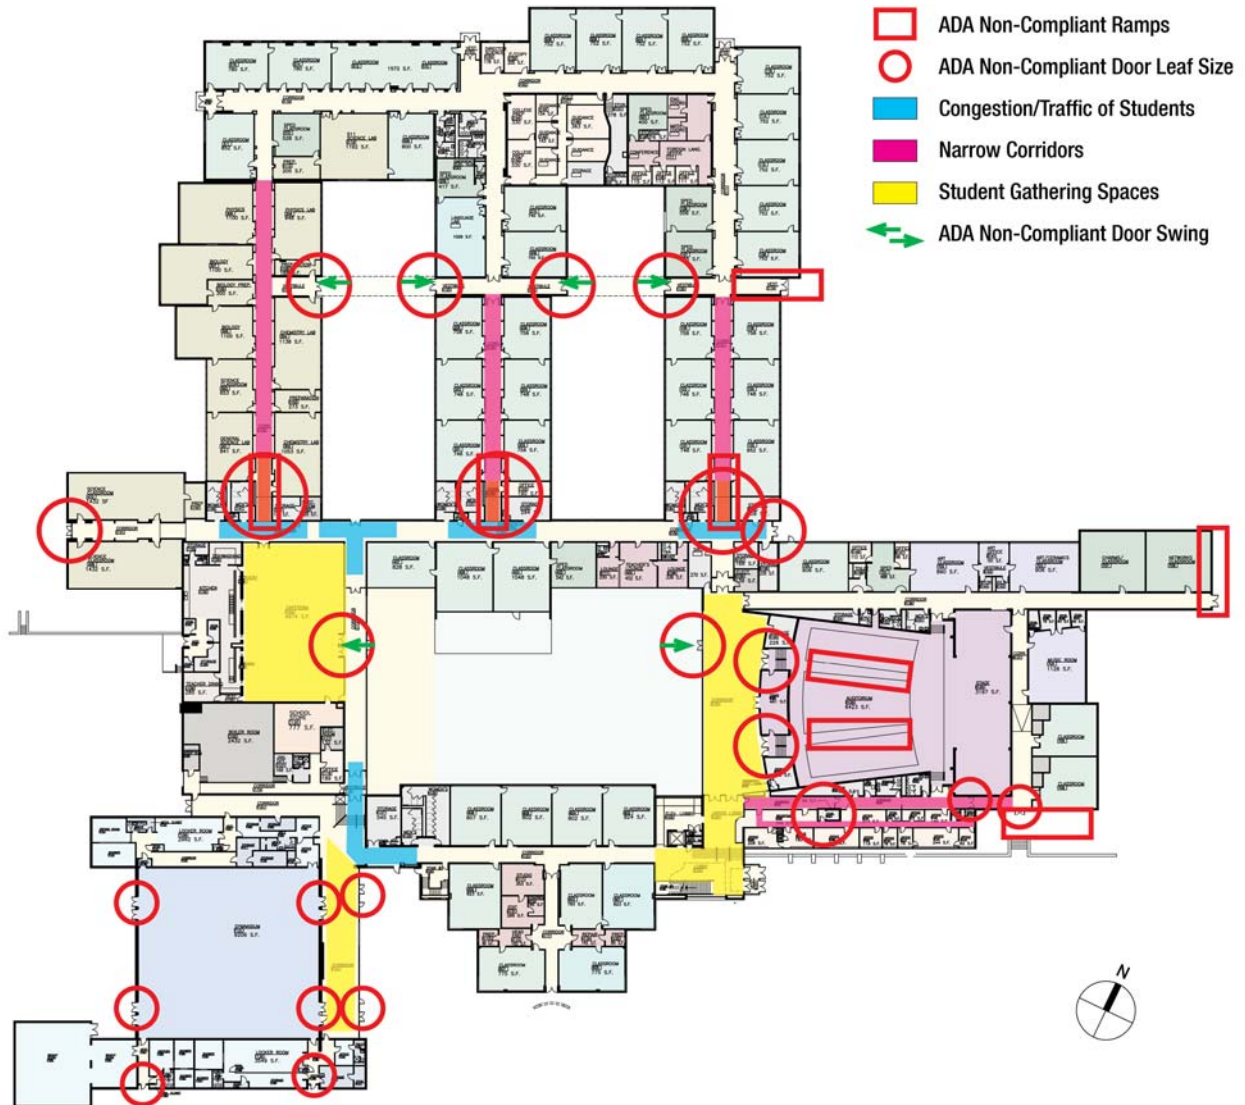
Diagram showing the areas of ADA compliance concern for egress and problem areas for congestion

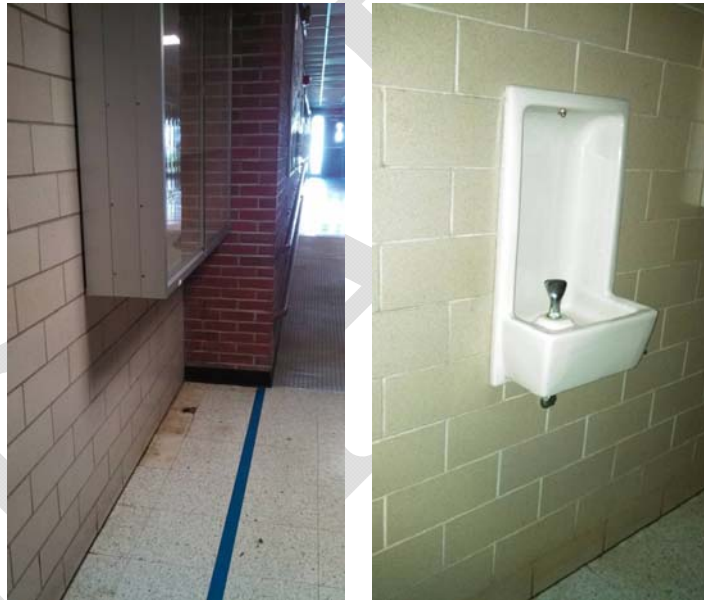
There are a number of projections in rooms and corridors along the accessible that do not meet the 4" maximum projection rules under the MAAB. These conditions pose a hazard to vision-impaired students and teachers. Included are drinking fountains as well as storage casework.

*Non-compliant projects for visually impaired students*

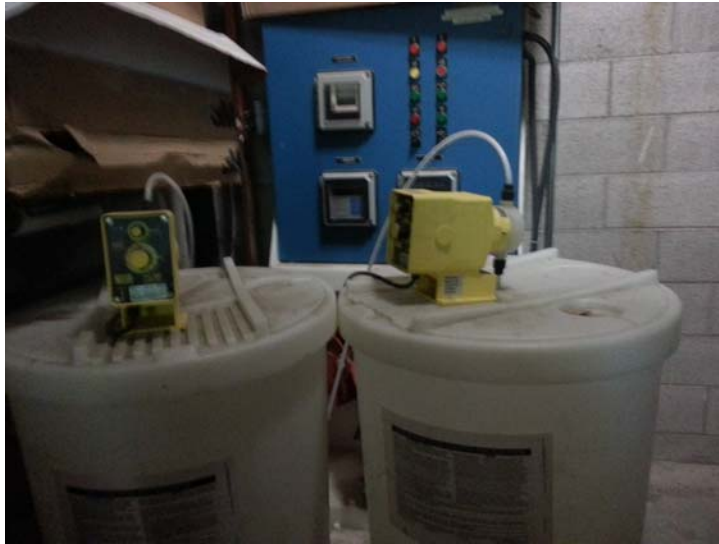
As part of the 1997 project, an Acid Waste and Vent system for the Laboratory Classrooms was installed. This system was piped to a pH adjustment system to be treated before discharging to the building sanitary drainage system. The pH monitoring system did not appear to be operational. Secondary containment is not provided for acid and caustic tanks creating a serious potential for a chemical spill.

*The pH is within a common storage room and has no ventilation or emergency shower.*

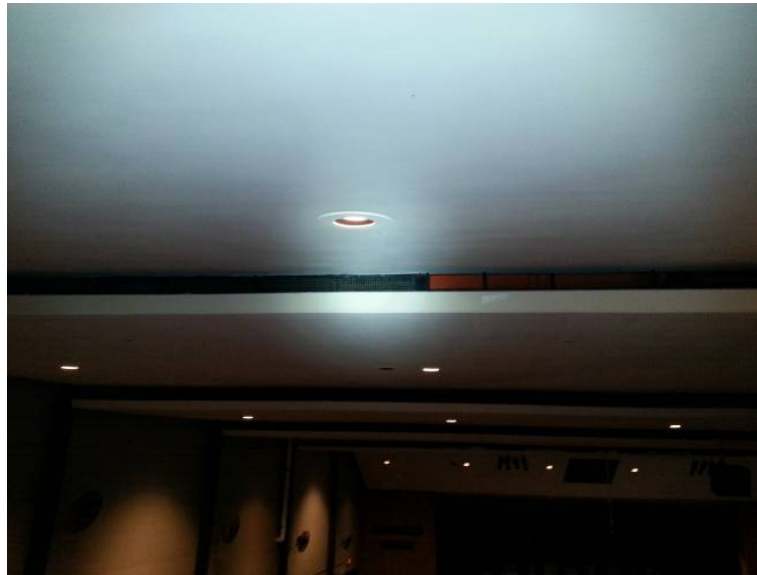
Additionally, two older air handling units have been abandoned above the auditorium space. These should be removed.

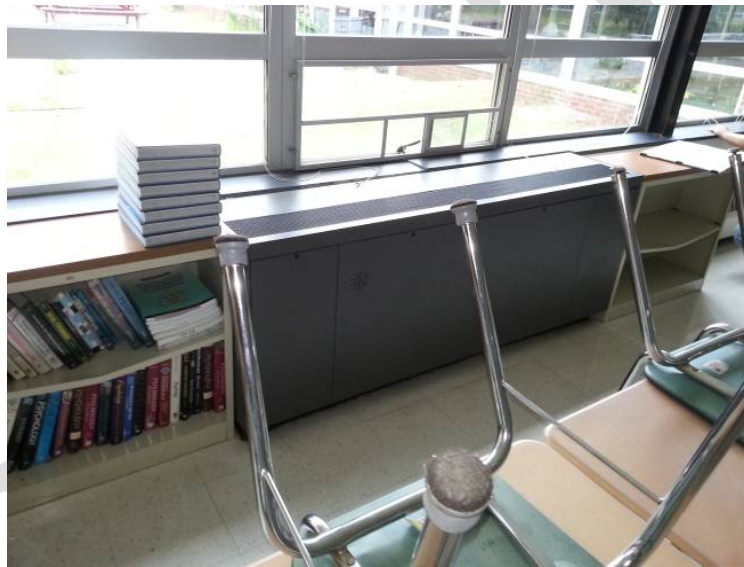
The original building classrooms are provided with a vertical discharge classroom unit ventilator located along the exterior wall of the building as well as finned tube radiation for unoccupied and nighttime setback periods. Each unit is provided with a supply fan which discharges vertically into the space, hot water heating coil with control valve which ties into the main hot water heating loop, return air drawn at the base of the unit, filters, and outside air drawn directly at the rear of the unit through a wall mounted louver. Each unit is controlled by a wall mounted thermostat. The interior areas of the cabinets appear to be well maintained. However, these units are approaching their maximum serviceable life of 18 years and should be replaced.

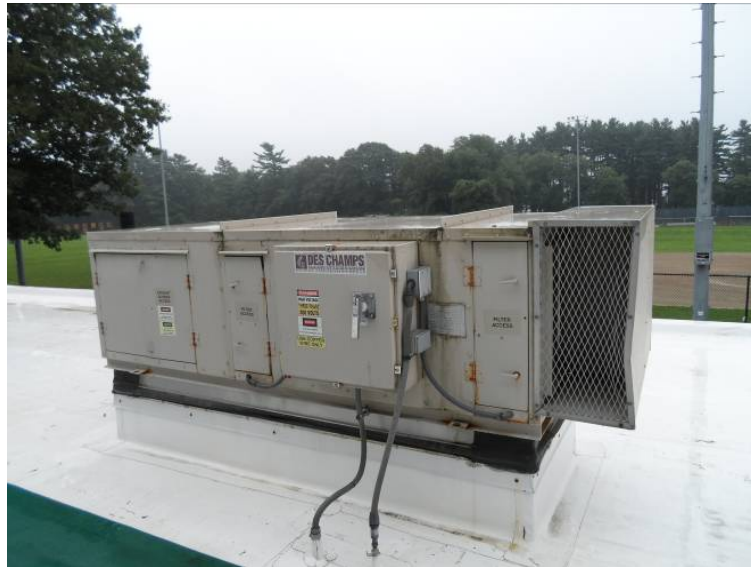
The boys and girls locker rooms are similar and are each provided with one roof mounted heat recovery unit tied to supply and exhaust ductwork routed within the spaces. Each unit is provided with a supply fan, exhaust fan, hot water heating coil, plate heat exchanger, and supply and exhaust filters. It is our understanding that these two units have caused many problems throughout the past 15 years apparently breaking down frequently resulting in several maintenance calls. The schools facilities group would highly recommend replacing these units.

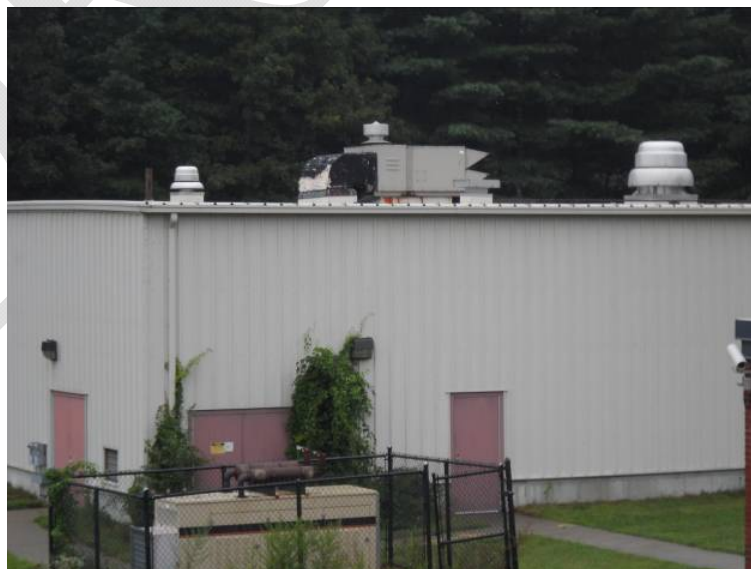
It is our understanding that the roof mounted makeup air unit is not performing and/or providing the necessary heated ventilation air and should be replaced.
