*March 26, 2014*

# SHARON HIGH SCHOOL

181 Pond Street | Sharon, Massachusetts

*Executive Report - 2013 High School Conditions Study*

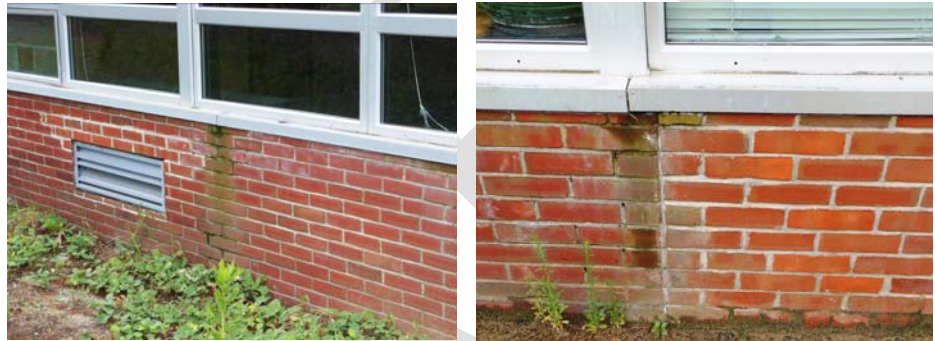
The exterior walls show evidence of water damage. Not only can this be seen from water stains on the exterior of the building, it can also be seen on the interior of the building as wall and floor damage.

Water damage on the exterior of the building throughout.

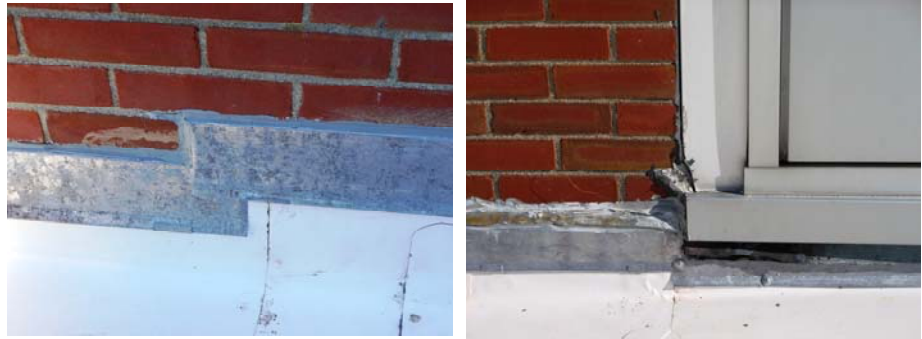
*New sealant added as a temporary solution blocks weeps creating water issues within wall*

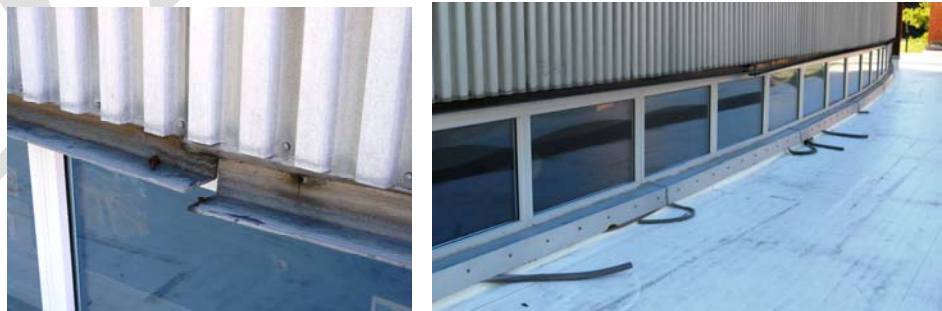
Damage is apparent at the west exterior wall of the auditorium. Missing bolts have caused the support lintels to become separated and closure panels to become loose. Additionally, at the window base, backer rods have come out of place which allows moisture into the building. Damage can also be seen on the interior of the building at this location.

*Damaged to exterior wall at Auditorium exterior - loose lintel and backer rods*

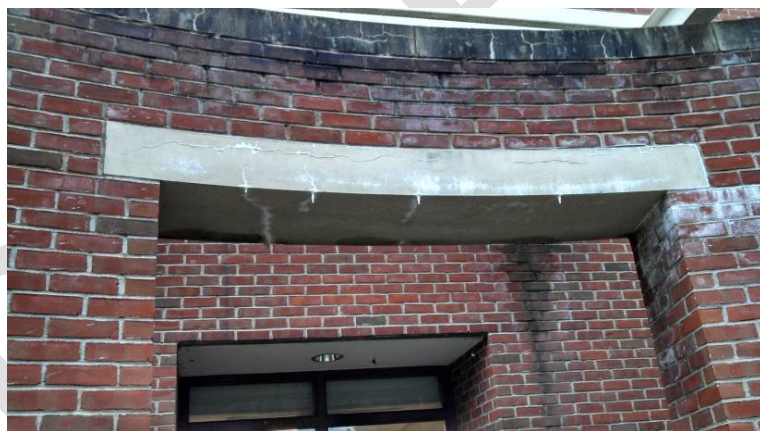
A number of walls exhibit approximately 12-24" of efflorescence at the base, indicating moisture issues within the exterior wall assembly. Additionally, in several locations, moss is growing in the mortar joints of the brick. This is another example of how water presence in the brick is adversely affecting the exterior wall construction.

Efflorescence seen at building entry archway

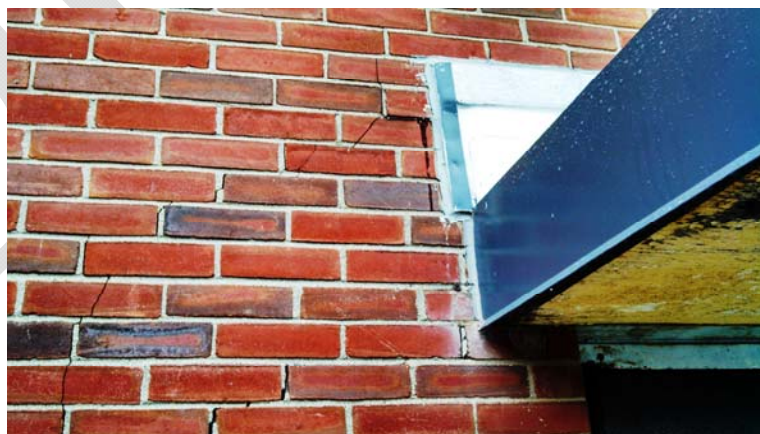
Evidence of brick settlement is apparent in many locations. At most exterior doors, diagonal cracks extend from the structural steel lintel away from the opening in both directions.

Brick settlement cracks at door openings (flashing damage).

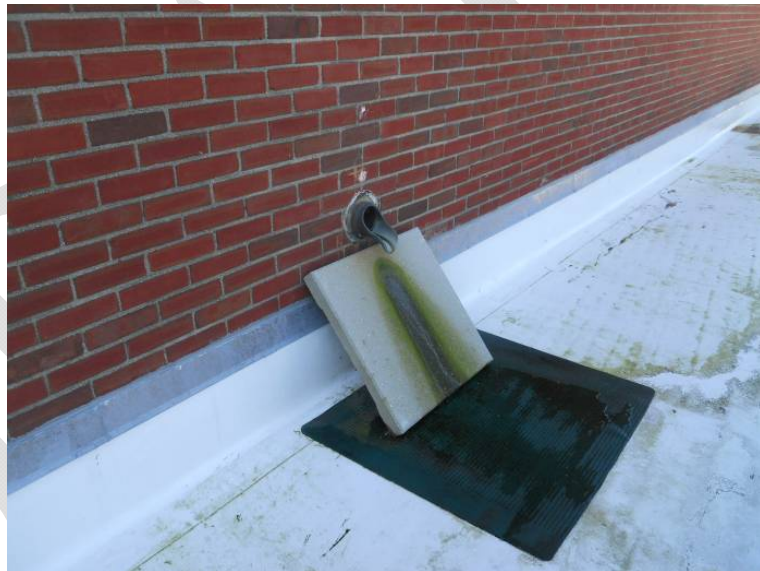
*Roof overflow drain dripping onto make-shift splash pad*

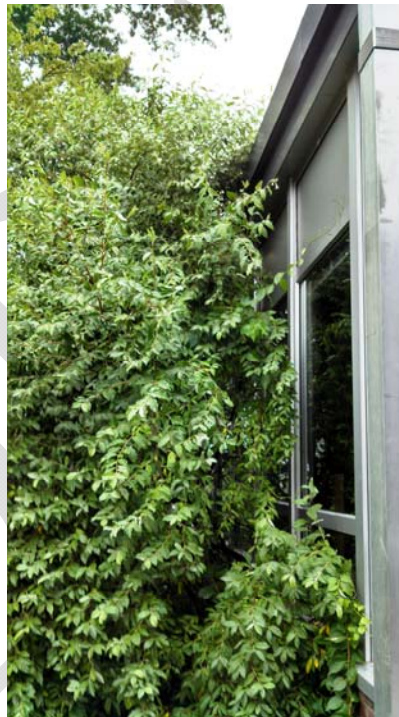
*Trees close to the building deposit debris on roof*

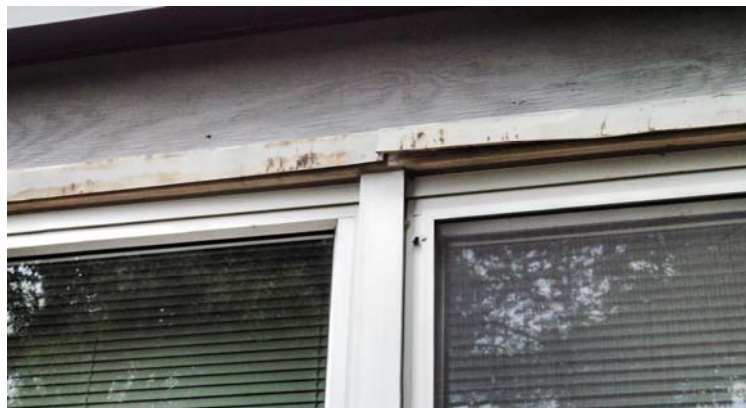
At the 1963 addition, portions of the facade above the storefront system were constructed of exposed painted plywood which is delaminating and in very poor condition. Although it has been maintained by repainting the plywood, the exposed plywood needs replacement. There is an operable lite at each portion of these units. Many of the insulated metal panel portions of the storefront have been vandalized.

*Damaged plywood and rusty damaged storefront*

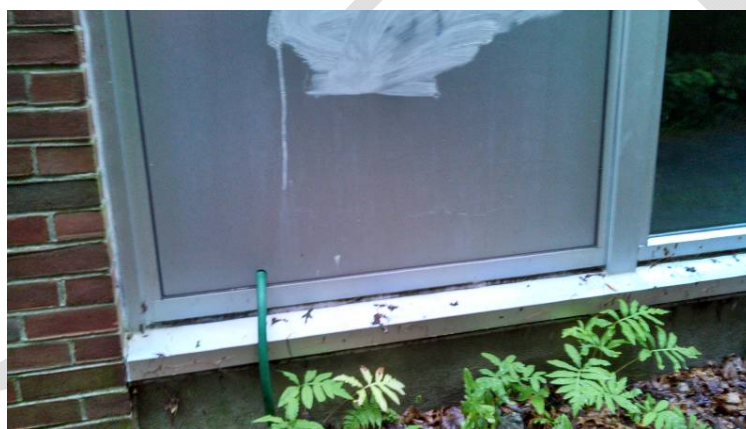
*Vandalized metal panel infill*

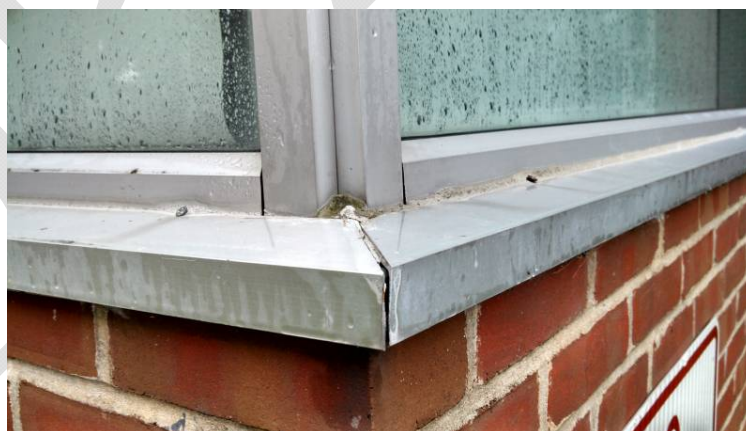
The exterior storefront sill extrusion at the 1997 addition shows lack of caulking at the exterior joints. Exposed rusty screws also show evidence of water damage. Also, sill overlaps have gaps which allows water to infiltrate the wall below creating moisture issues. Several of the snap-on mullion caps have been dented or damaged and need replacement. Some of the storefront gaskets are either loose or have fallen out of place.

*Exterior sill extrusion with missing caulk and rusty screws*

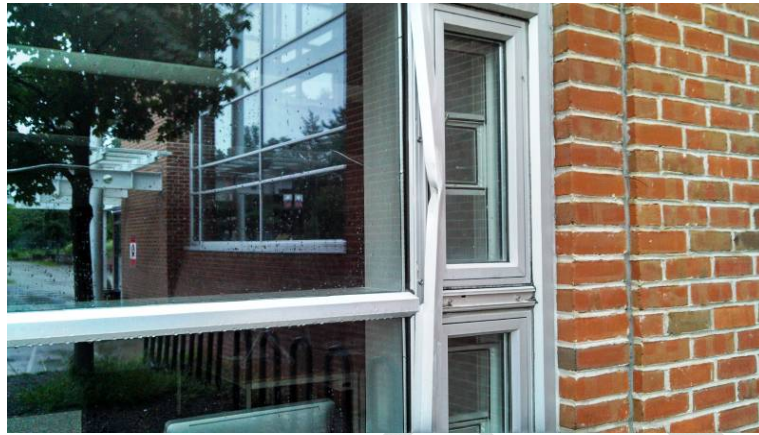
*Damaged snap-on mullion cap*

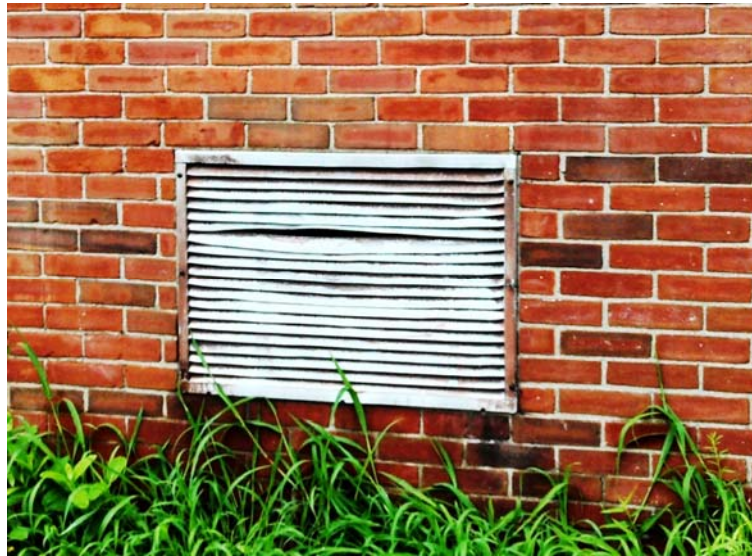
Louvers and vents for classroom and office HVAC units appear to be in fair condition, although sealant around them needs to be replaced. The large mechanical equipment louvers are in various states of disrepair, several having damaged or missing blades.

*Bent blades on mechanical louvers*

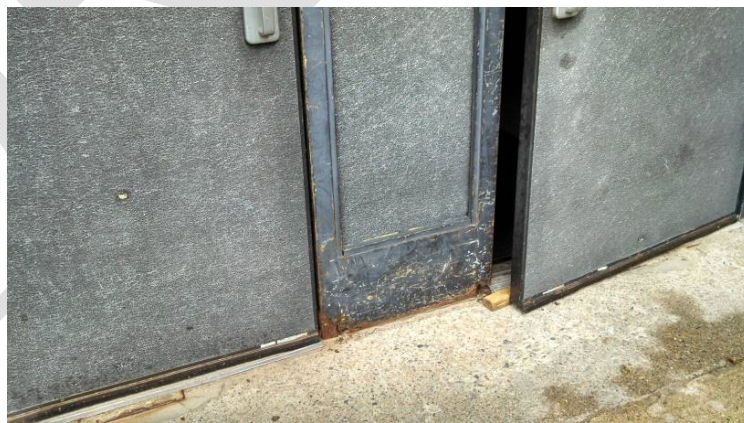
Doors and frames at the from the original building and the 1963 addition still remain and are in poor condition and in need of replacement. The doors sit within metal frames and show signs of rust and deterioration in many locations. Most of these entries are missing some of all of the caulking. This creates a thermal issue at these entries, specifically where there are not vestibules located inside the space.

*1956 Building original metal doors exhibiting rust*

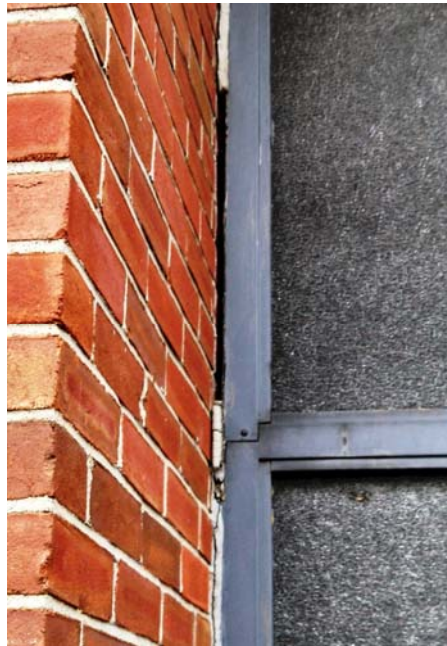
*Exterior door systems showing portions of caulking completely missing*

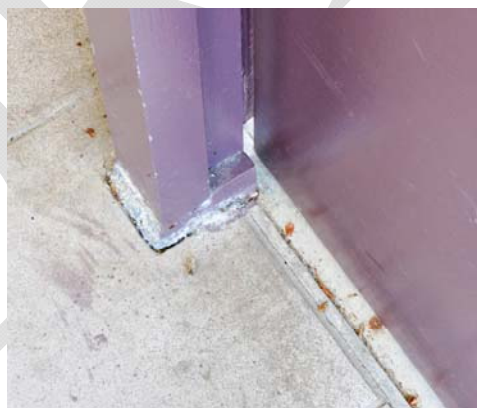
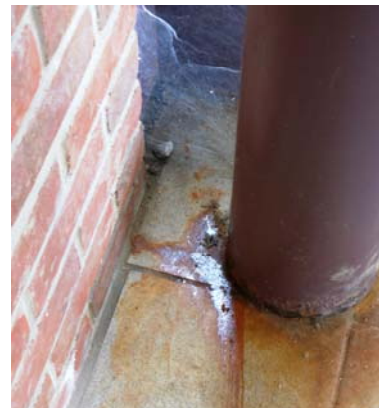
Main entry doors that do not latch closed tightly.  
Rust damage and broken tiles showing signs of water damage

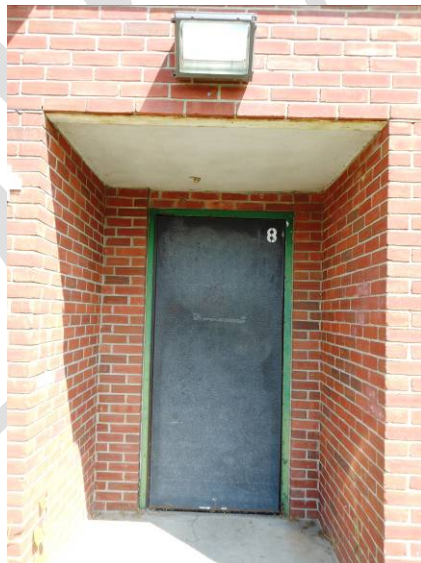
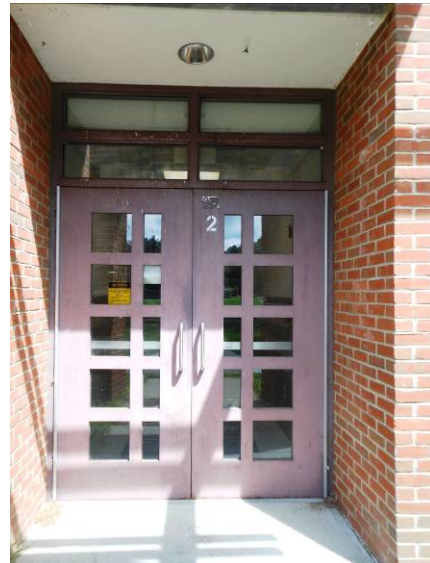
Gymnasium egress doors with lintel damage 1997 addition doors with rust damage above

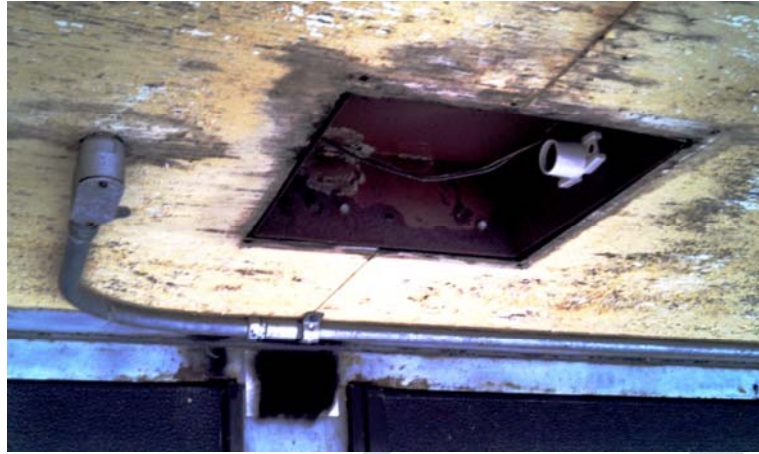
Many of the soffits appear to be original wood or plaster soffits. They show extensive mold/mildew presence and water damage. At exterior doors, many of the soffits have been removed and show exposed painted metal deck and are in very poor condition. In these soffits, exposed wiring and loosely attached lighting creates a dangerous condition.

Exterior plywood soffit showing mold and abandoned light fixture

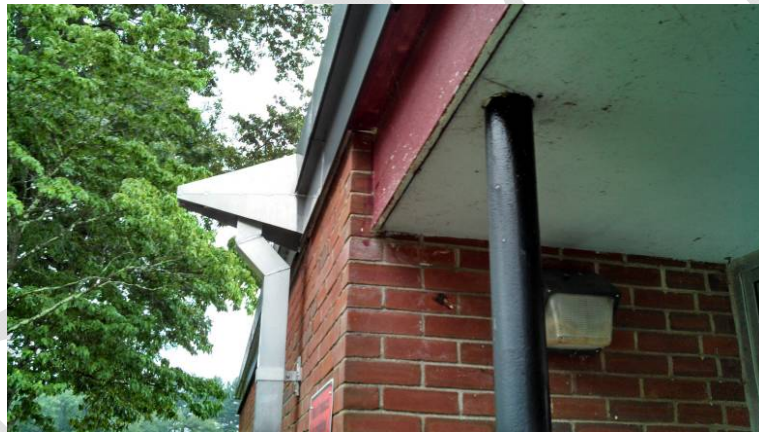
Exterior plywood soffit showing mold

In some areas the wood soffits have been repainted recently, however the mold and chipping paint indicates that there is dry rot and the wood soffit and fascia trim needs replacement.

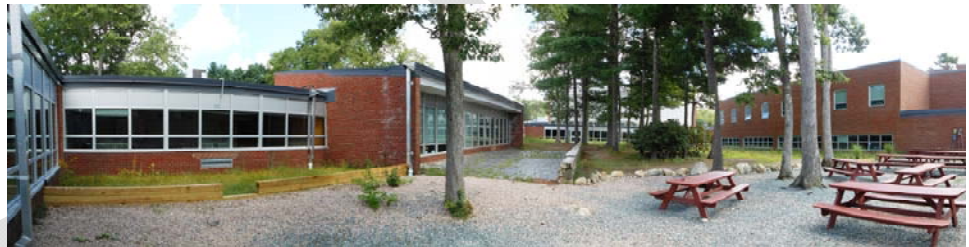
*Southern courtyard panorama showing eating area*

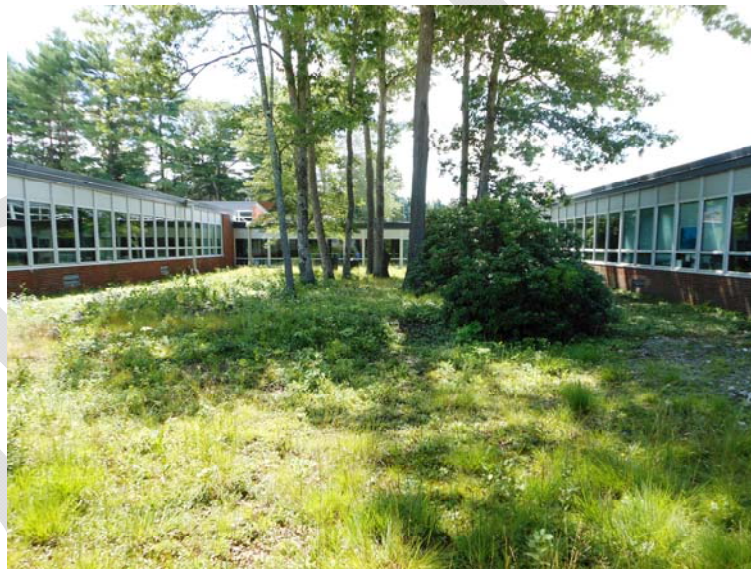
*Northeast courtyard where ducks inhabit*

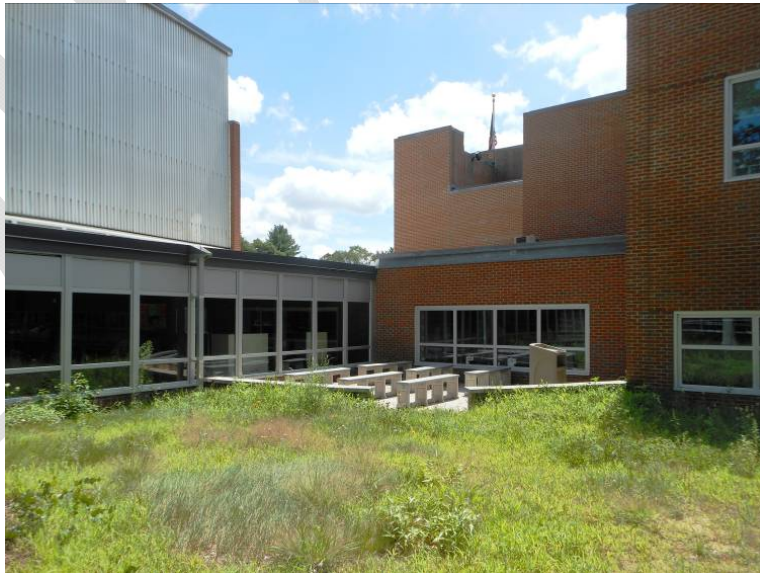
Recently, an outdoor learning space was added in the southern courtyard however tall grasses impede foot traffic from the interior spaces to the outdoor classroom. It also will need modifications to the landscape in order to provide accessibility to the space.

*Outdoor classroom space in southern courtyard*

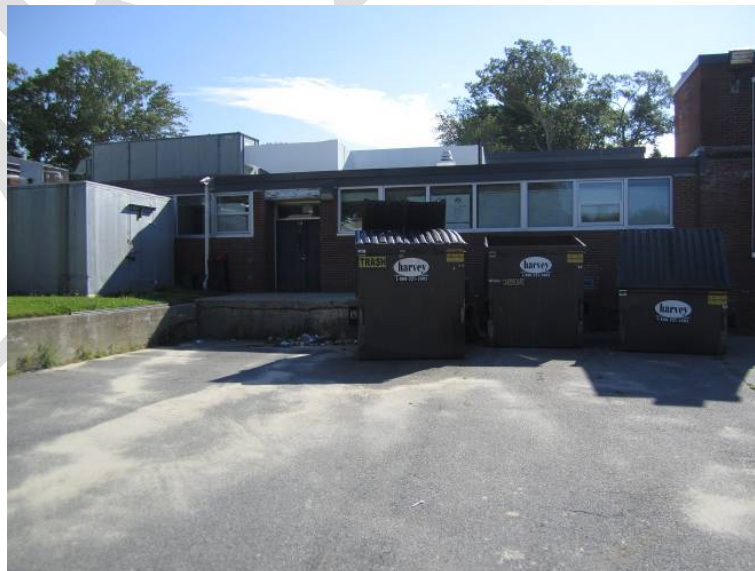
*Haphazardly placed dumpsters at loading dock area*

The space provided at the loading dock in its current configuration is adequate although the sporadic placement of the dumpsters impedes access to the loading dock stairs.

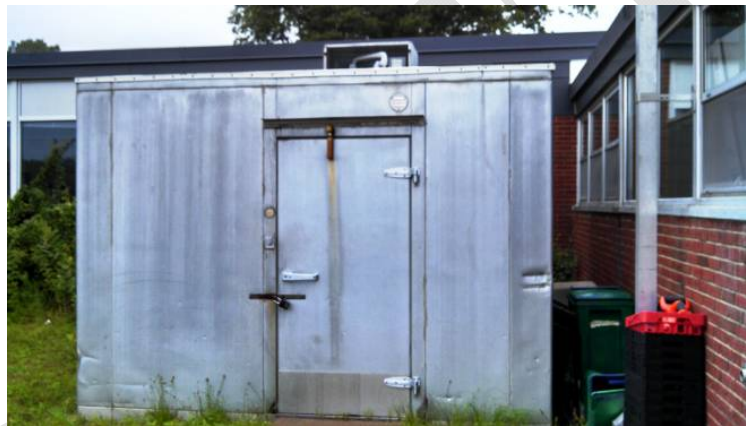
An outdoor refrigerator/freezer is located in the loading dock area. This transfer food through an unsanitary outdoor space before moving indoors. The space between it and the exterior building wall stores miscellaneous items. The main kitchen loading dock is not equipped with a call button.

Outdoor refrigerator and clutter at loading dock

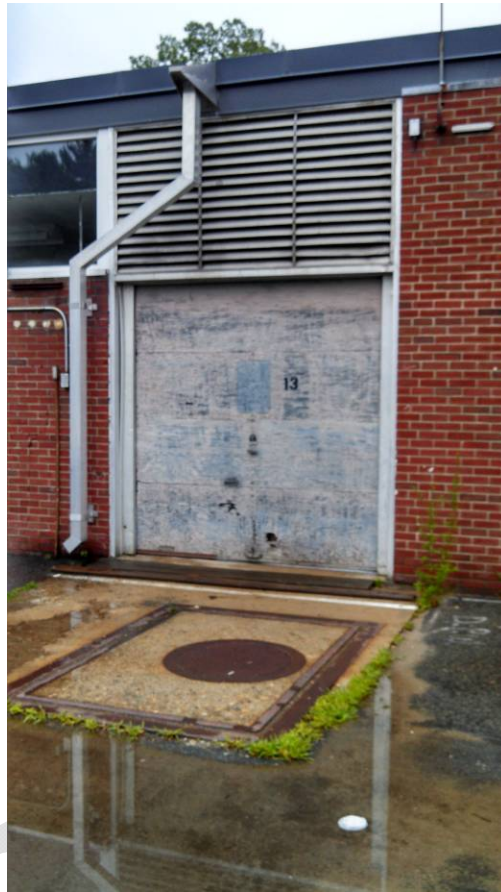
The custodial service door is in poor condition and is in need of replacement. Also services, conduit, and wiring on the exterior of the building are poorly organized and in various states of disrepair.

*Plywood custodial service door*

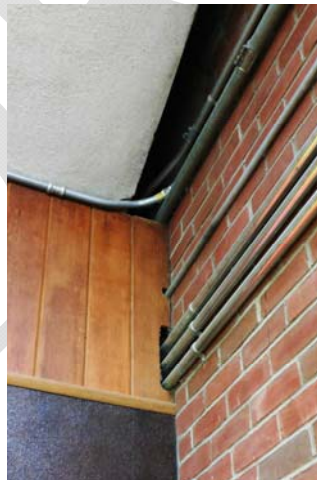
The walls on the Auditorium lobby have a wood paneling which is in poor condition. On the interior of the Auditorium walls are painted CMU with wood baffles at the sides and rear of the auditorium. Dust and debris accumulate behind the wood system. The Proscenium wall is clad in wood veneer from floor to ceiling. Additionally, at the auditorium lobby, plastic panels have been added to protect the wood walls. This material may not meet building code for flame spread rating. Pipes leaving the emergency electrical closet underneath of the auditorium lack the required fireproofing to maintain the 1-hour rating required by building code. Carpet throughout the space is in poor condition and dated.

Missing required fireproofing at 1 hour rated fire wall and fiberglass wall panels

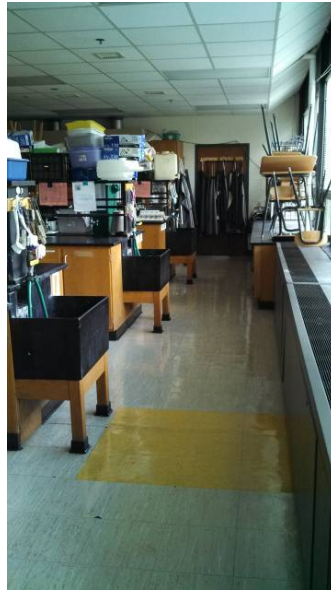
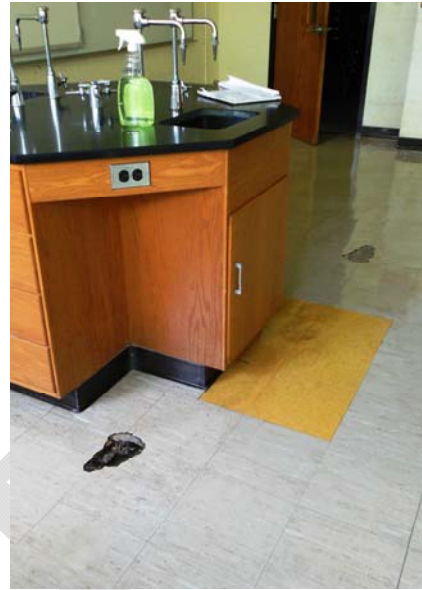
The flooring in the original building as well as the 1963 addition has not been updated and it is beyond its useful life. In the classrooms and corridors mismatched vinyl composition tile has been patched in where worn tiles were removed.

*Patched or mismatched tile infill*

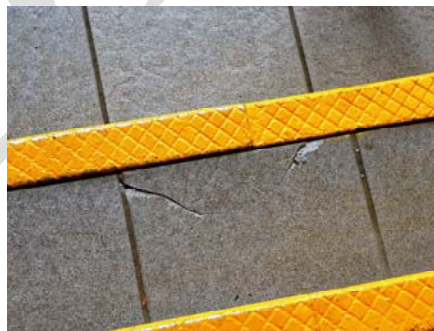
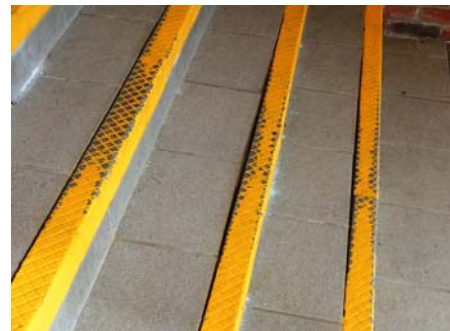
Broken floor tile and damaged nosings at building lobby

Tile and metal nosings at the entry stairs have also been worn in the heavy traffic areas. Flooring in the 1997 addition including the carpeting in the library and the VCT in the classrooms is generally in fair condition but the carpet does show signs of wear in high traffic areas. The carpeting in the original building, the 1963 addition, and the first floor of the 1997 addition all shows sign of wear however it is in good condition.

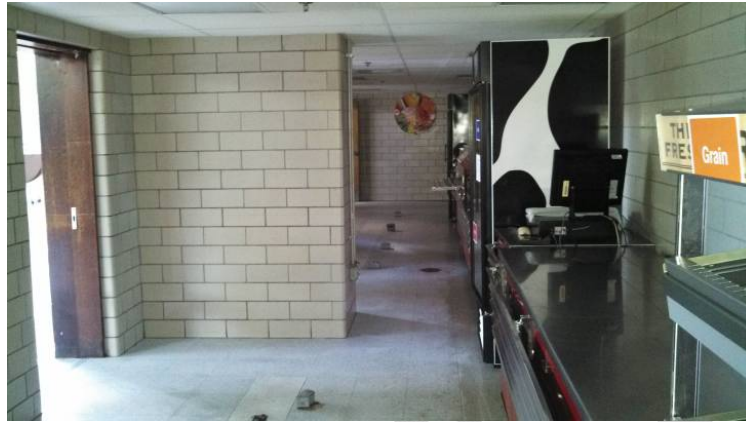
Locker areas and the gymnasium lobby have polished concrete floors in good condition. In the locker room shower areas there is ceramic tile in poor condition. Gymnasium wood flooring is in good condition. Kitchen VCT flooring is chipped and damaged. Generally, all original floor tiles are in fair condition however tile at exterior walls and building entries is severely damaged and should be replaced in those areas.

*Kitchen VCT flooring*

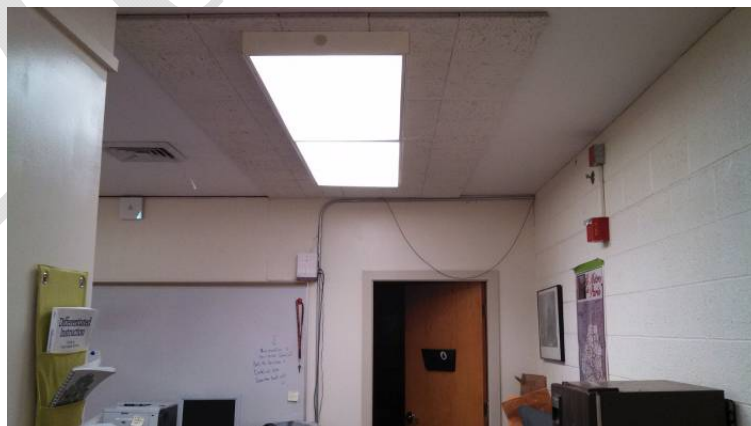
Original 12x12 ACT in teacher prep area

Some spaces have 12"x12" concealed spline acoustical ceiling tiles however these are in very poor condition. Most noticeable is the damaged and missing tiles in the language lab.

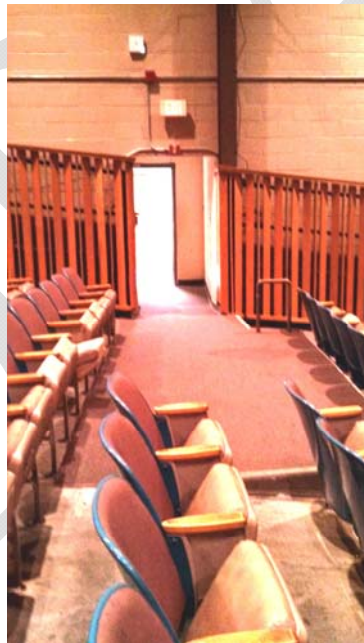
During the 1997 addition, accommodation was made for an accessible entrance into the auditorium. This entry is located off of the north corridor and provides a landing area only in one portion of the viewing area. As mentioned above, this does not meet accessibility code because the accessible route must follow the primary entry for the general public. Additionally, accessibility code requires viewing areas throughout the space.

*ADA Accessible viewing area located next to accessible side entry*

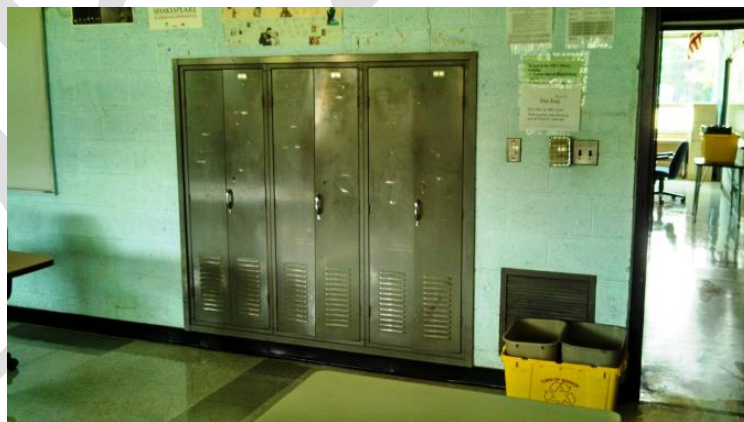
Most classrooms also have 3 double wide lockers for teacher storage. These lockers are in poor condition, are dented, and need replacement.

Teacher storage lockers

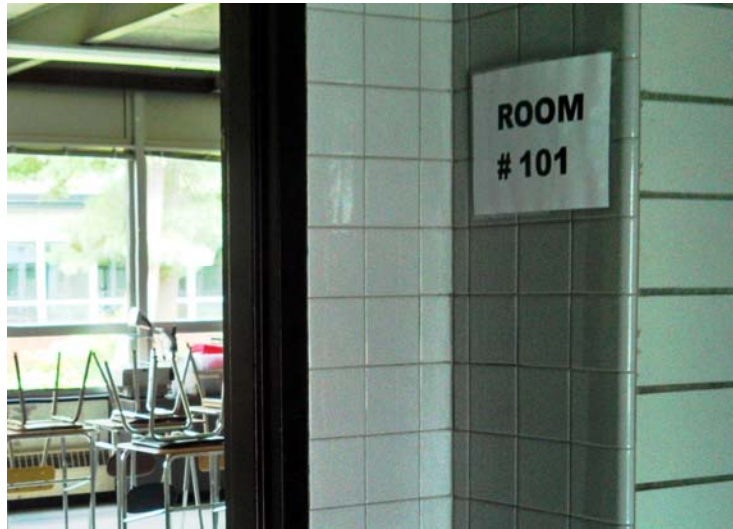
Typically, each room has two different signs - one temporary laminated paper sign with the room number, and one permanent sign with the room number. The permanent classroom signage is inconsistent throughout the building and in some cases is illegible due to age.

*Classroom laminated signage*

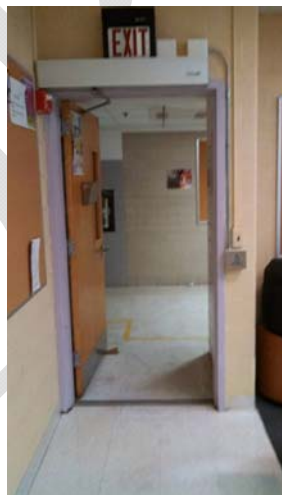
Corridor way finding is minimal for the layout and geometry of the building. It appears that when the original building was constructed, strips of colored flooring material delineated the different wings of the school. Over time this philosophy has been abandoned.

*Yellow striping in corridor evidence of wayfinding*

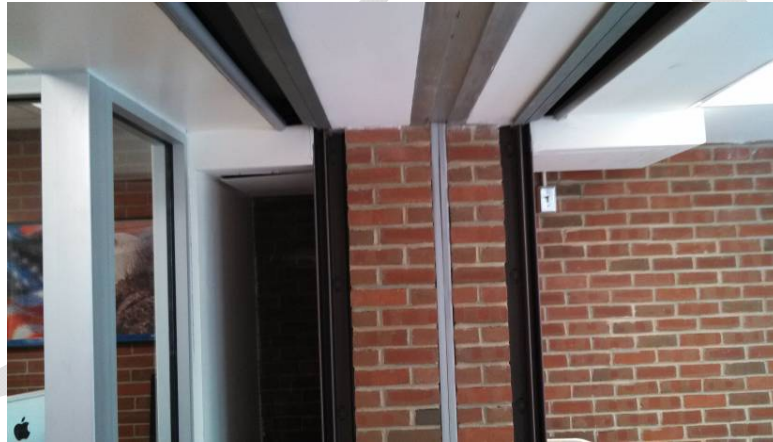
Fire shutter at upper lobby

Wire glass is present at the fire doors that separate the corridor lengths. This glass may not be compliant with current code without modification or the addition of a glazing film.

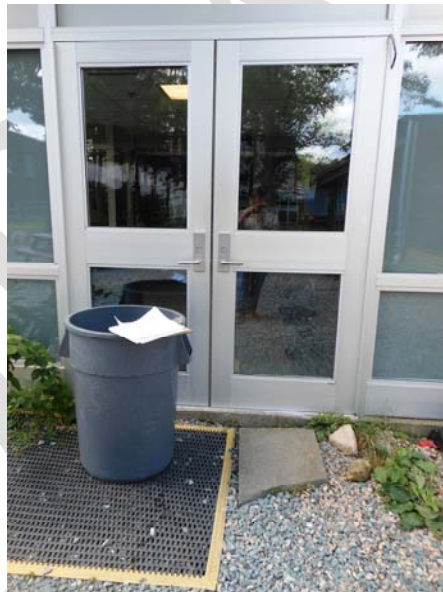
The courtyard includes an outdoor classroom and was renovated to include outdoor seating and gathering space for students. The path to the outdoor classroom may need to be updated to meet accessibility standards. Additionally, steps down from the door openings into the courtyard render the space inaccessible for students with disabilities. The doors to the northern courtyard open air walkways have knobs which are not code compliant and remain locked for most of the school year.

*Non-compliant entry into courtyard*

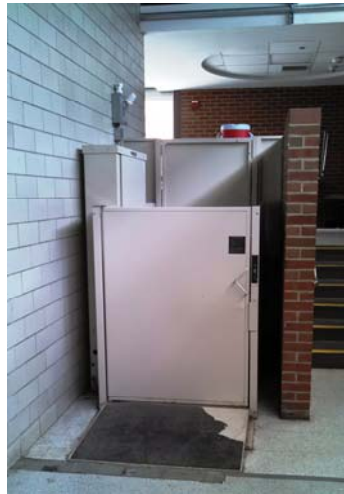
*Lift at athletic wing*

The existing elevator provides accessibility to the second floor library and office spaces and meets current code. Near the gymnasium there is also a lift that provides accessibility.

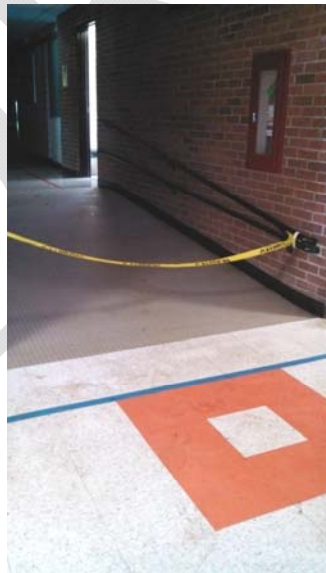
There are several interior ramps linking the northern classroom areas of the building to the lower southern portion of the building. These ramps have a 9% or greater slope which does not comply with the current accessibility code. Exterior ramps do not meet current building code. Modifications to the handrails and slope may be required.

*Non-compliant ramp*

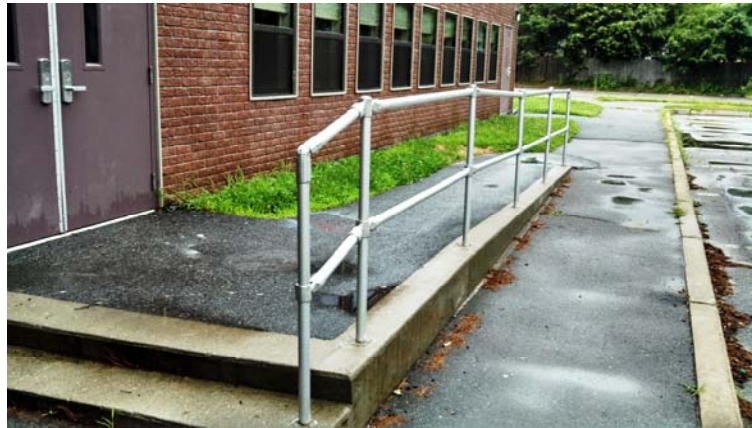
Non-compliant ramp

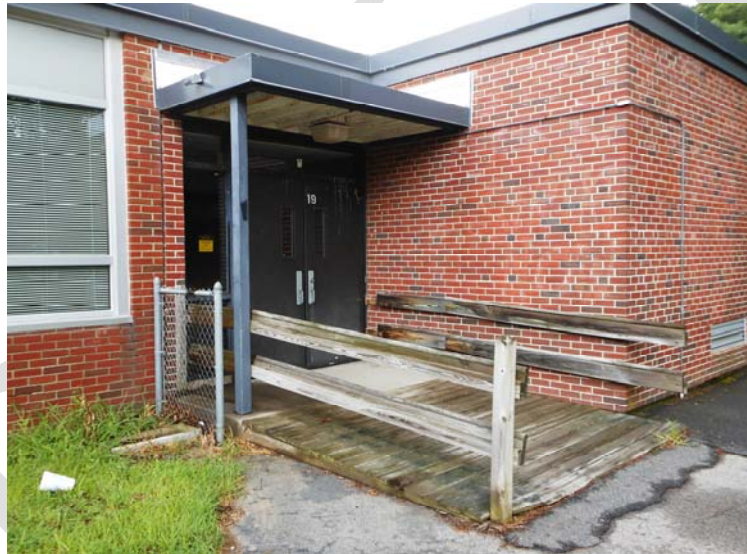
Non-compliant ramp

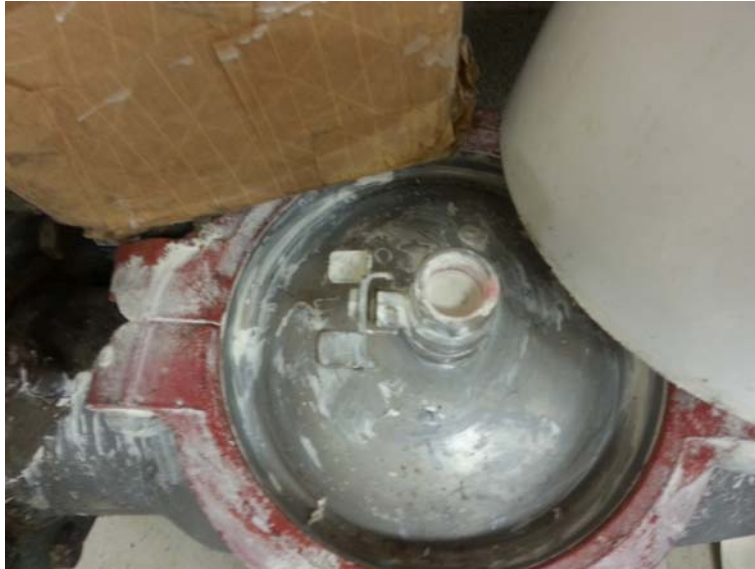
The fire water service is extended to building 'A' on the south side through a 6" CLDI pipe. Once inside the building, the system is equipped with a double check valve assembly (DCVA), backflow prevention device. The DCVA is in need of service due to a paint spill filling one of the test ports.

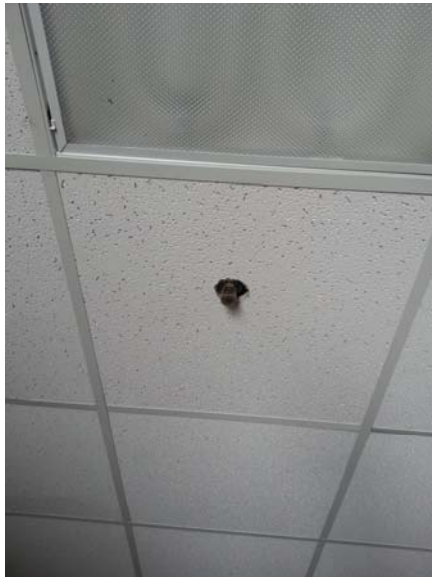
During the site visit, heads in multiple corridors were observed without escutcheons. This is typically due to a bow or sag in the ceiling structure and cause a delayed response in sprinkler activation.

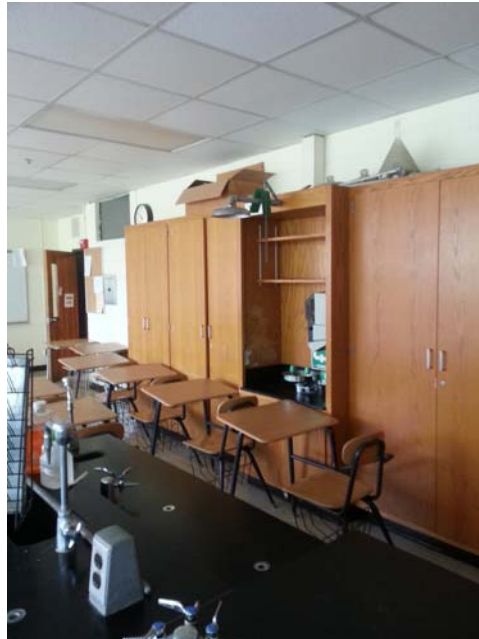
The lab gas system is seriously undersized and lacks emergency gas shut-off valves in multiple science class rooms.

No evidence of ADA compliance was seen in the Laboratory Classrooms.

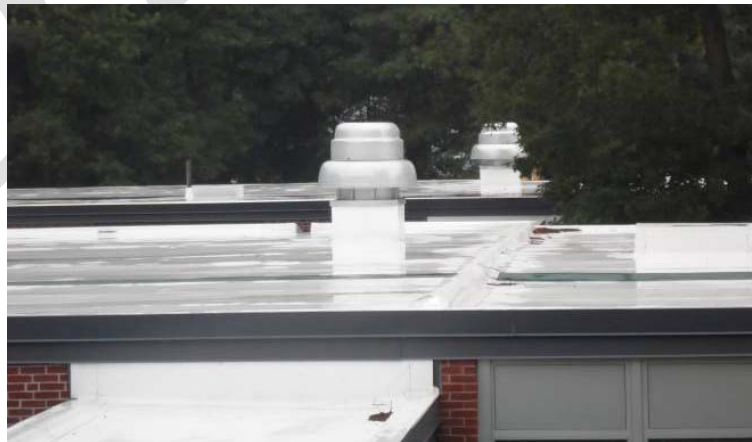
Located on the interior wall of each classroom is a wall mounted exhaust register which communicates to a roof mounted exhaust fan through a series of galvanized sheet metal exhaust ductwork. The interior of all registers were extremely soiled. However, it does appear that all classroom associated roof exhaust fans are in good condition and operating properly.

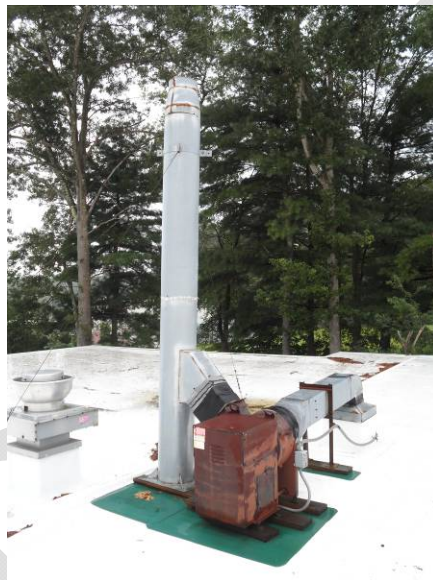
The roof mounted fume hood exhaust utility fan is in very poor condition and should be replaced.

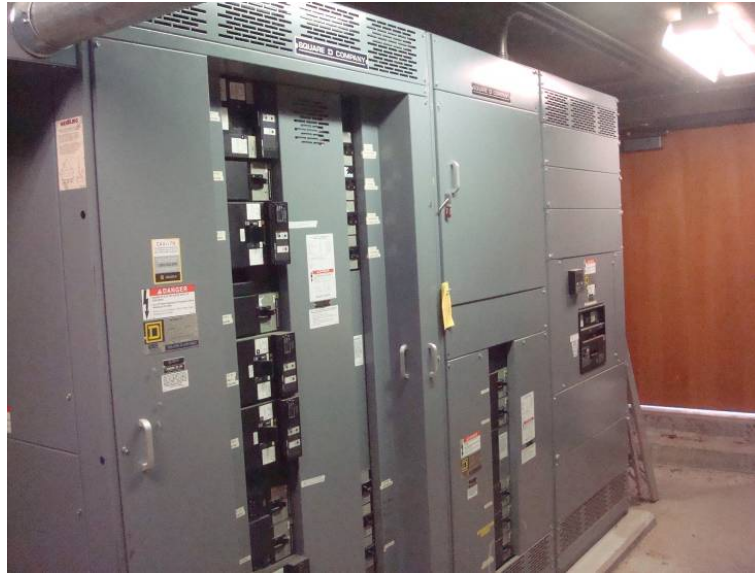
| Main Electrical Switchboard

The main switchboard is in a good working condition, but its installation in the electrical room is not in compliance with the latest Electrical Code (number of the egress doors and lack of door panic hardware).

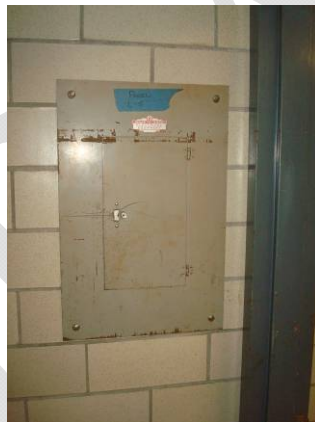
Panel L5

The branch circuit panels L1 to L5, L7 to L14, and P2 to P7 of 1956 and 1963 construction exceeded their expected useful life.

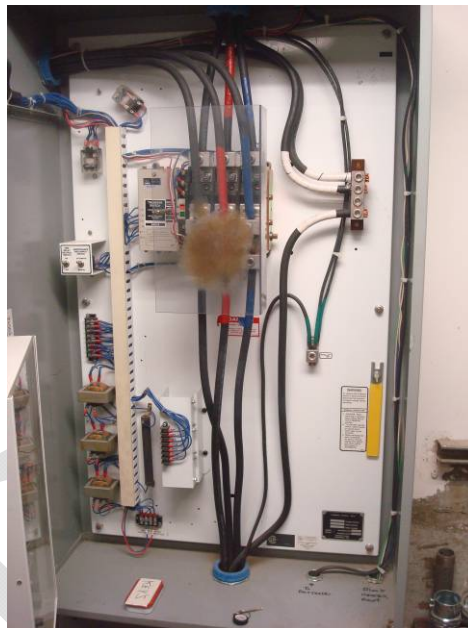
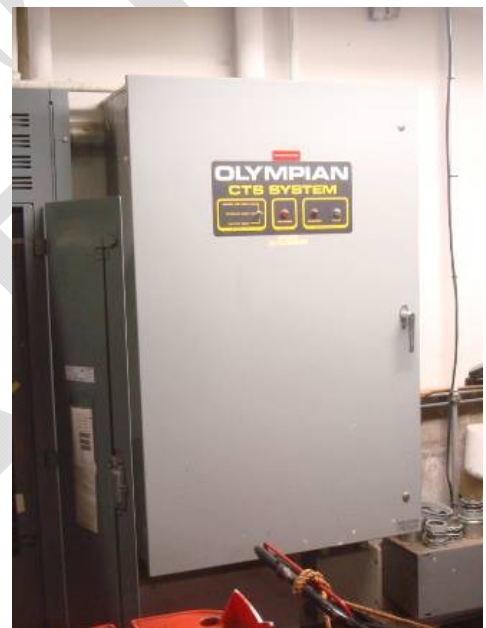
The standby ATS#2 and distribution panel SDP are located in the boiler room, and they are in good working condition. The panel SDP had been sized at 400Amp to support multiple boilers, pumps, kitchen panels, walk-in refrigerator, AHUs, and WWTF, but the 100kW generator, ATS#2 and 225 Amp standby power feeders have been undersized for the design load. As a result, the standby power feeder overheating required some loads be removed from the SDP panel.

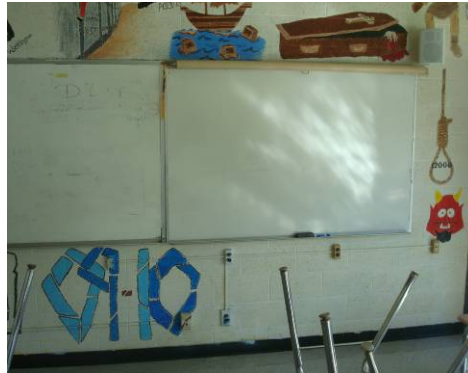
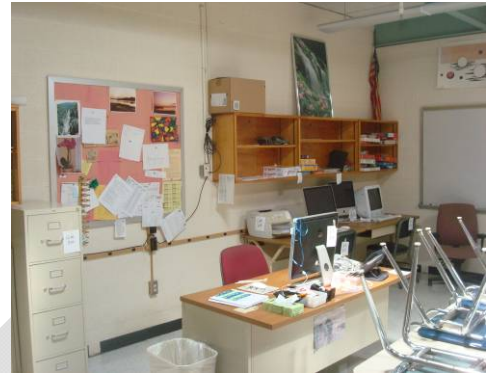
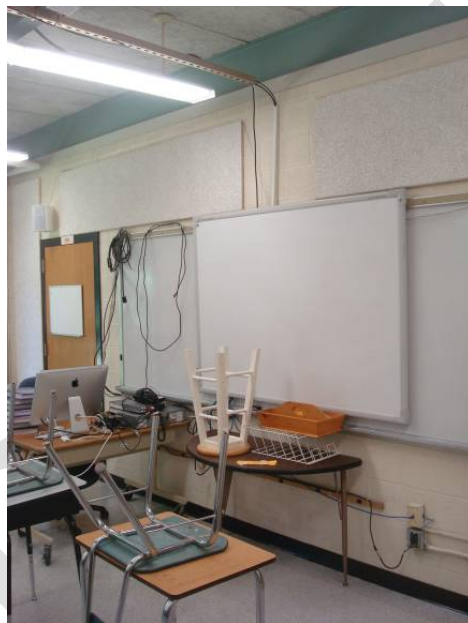
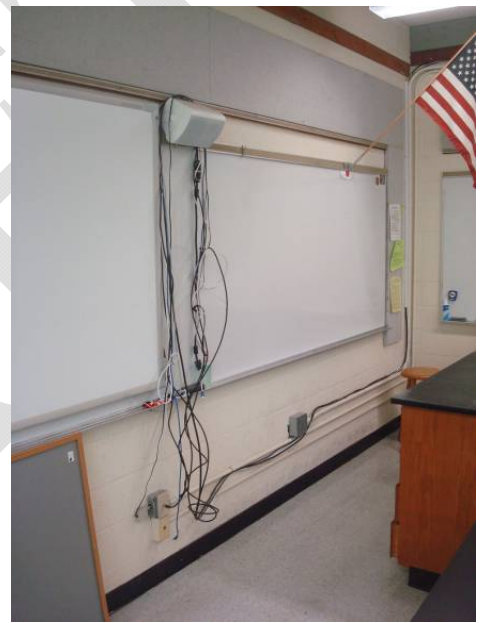
Typical Original Classrooms

Based on appearance, majority of the receptacles are in fair condition, however the branch circuits conductors (installed in 1956 and 1963) have exceeded their expected useful life.

Typical original (1956 and 1963 construction) classrooms have been provided with just few duplex receptacles – one receptacle on front and back walls. Most of these receptacles are not in ideal locations for today's teaching methods. As a result, the long extension cords (a code violation) or supplemental surface mounted devices and surface plug-in strips have been added over time to accommodate the technology equipment (a teacher' computer, smart board, etc.). In some cases (e.g. classroom 511), the circuits serving the plug-in strips are undersized that leads to the circuit breakers tripping.

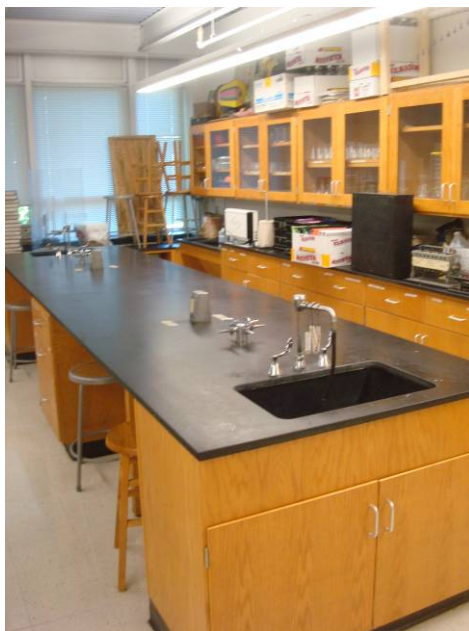
Science Room 307

The benches in the Science Labs are provided with the duplex receptacles. The receptacles in proximity of the sinks are of the GFI type in the some labs (e.g. room 307) and in the prep rooms as required by the Electrical Code, but there are non-GFI type receptacles in the other labs (e.g. rooms 302, 304).

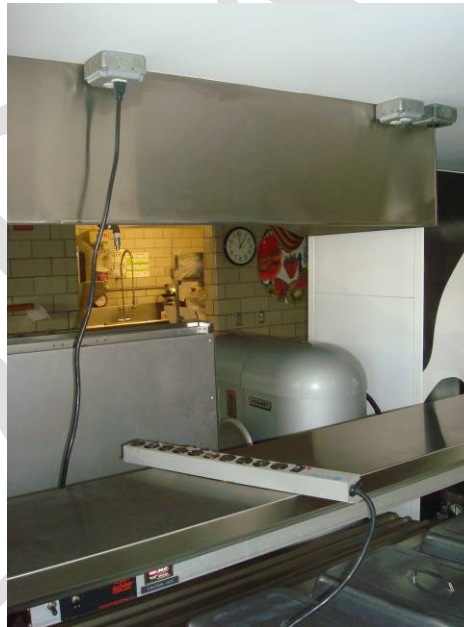
The duplex receptacles in the kitchen area are not of GFI type that is required by the Code. Also, use of the extension cords creates unsafe operational conditions.

Kitchen non-GFI Receptacle and Cord

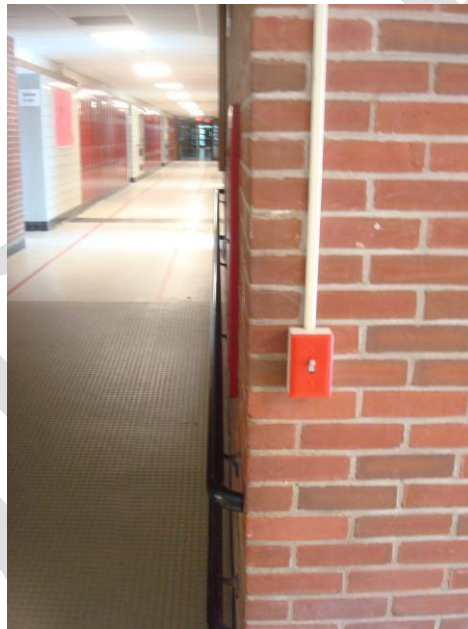
| Local Switch for Emergency Corridor Lights Control

Both normal and emergency corridor lighting fixtures are controlled by the local manual switches. The bypass relays are provided to automatically turn on emergency lights in a case of utility power failure. Lighting control doesn't comply with the latest Energy Code that requires automatic lights OFF control at unoccupied night time.

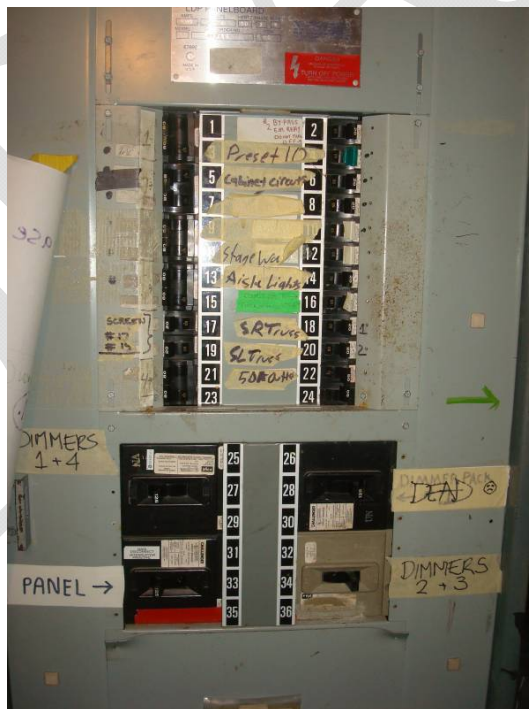
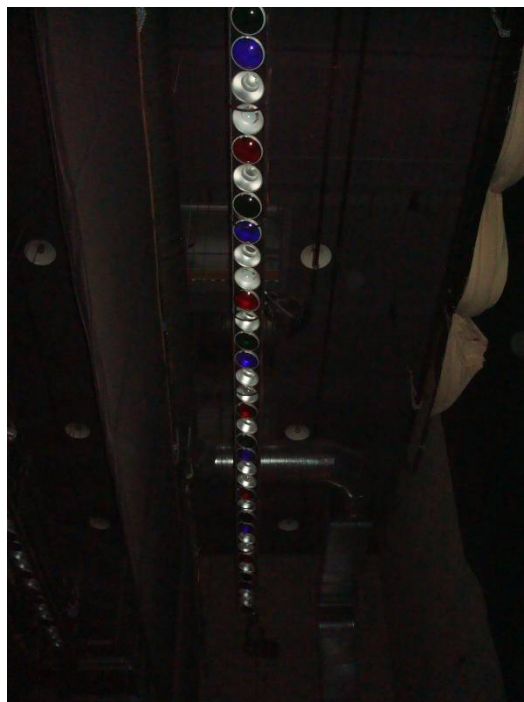
Auditorium house and theatrical dimming system are in very poor operational condition and are obsolete. Under 1997 project scope of work emergency lighting has been added on stage with the bypass relays to turn these lights automatically upon fire alarm or utility power failure.

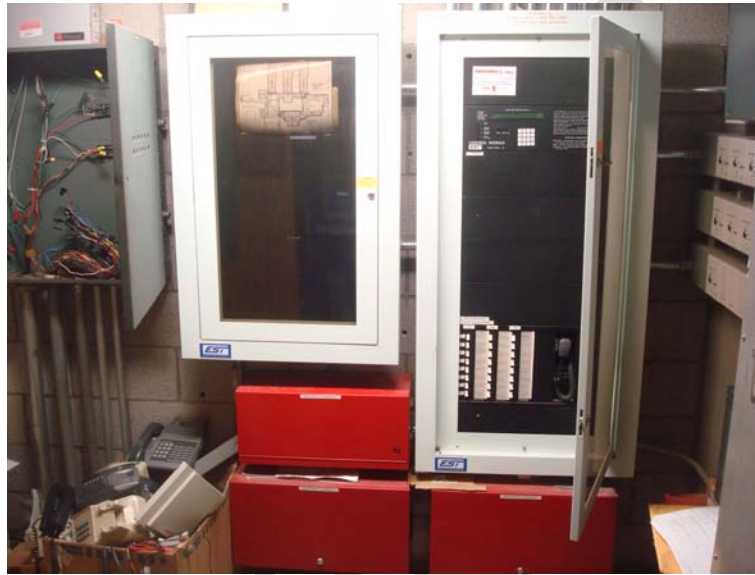
Fire Alarm Control Panel (FACP)

The master voice evacuation FACP (manufactured by EST) is installed in the electrical closet adjacent to the main electrical room. A Fire Department connection cable is installed underground from the FACP to the exterior master box installed on the building front wall. The remote alarm/test stations of the all duct type smoke detectors are located adjacent to FACP. The FACP is an old technology and at a minimum requires a system software/hardware upgrades.
