*March 26, 2014*

# SHARON HIGH SCHOOL

181 Pond Street | Sharon, Massachusetts

*Executive Report - 2013 High School Conditions Study*

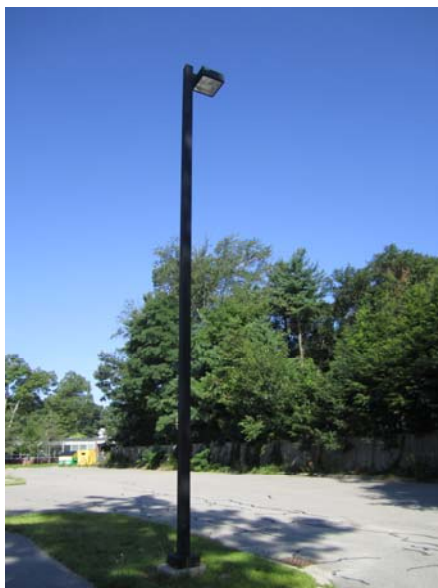
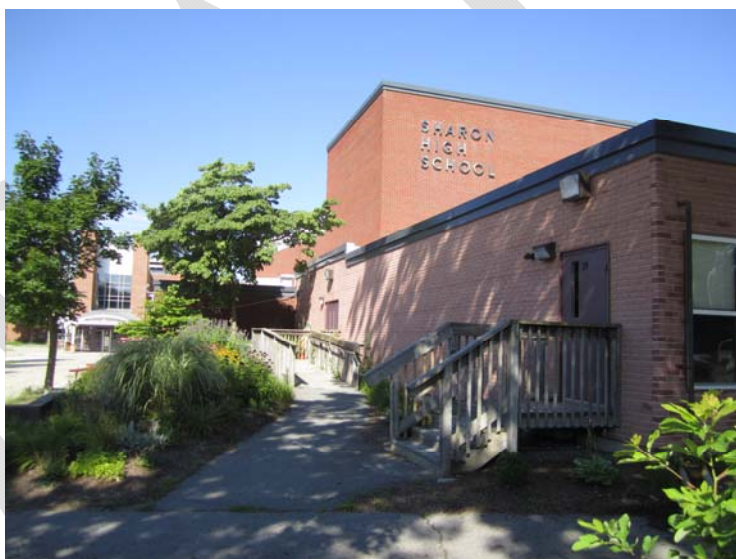
The roadway and parking lighting standards are the pole mounted HID fixtures. The exterior, egress and entrance points to the building lighting use either surface mounted under the canopies, wall-mounted packs or floodlights. Neither of these fixtures provide cut-off lighting distribution. The new wall packs installed on the weight room addition are of the full cut-off distribution type.

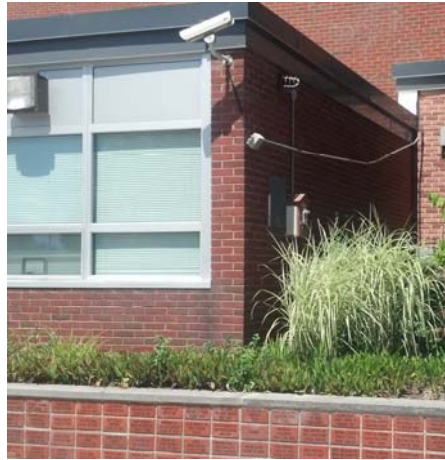
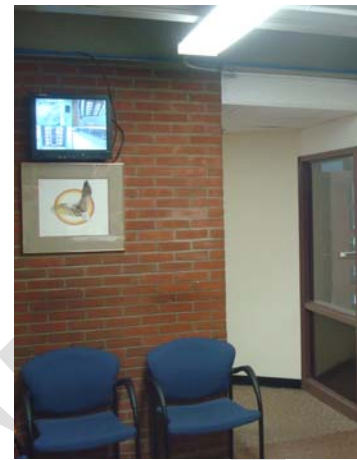
CCTV Camera and Monitor

The school is equipped with eight analog, outdoor CCTV cameras that are approximately 10 years old. The CCTV cable plant is coaxial. The cameras are recorded to a Philips digital video recorder with limited performance features. The cameras are monitored on a small screen in the Main Office.

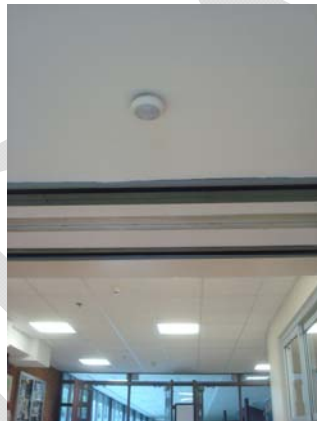
Typical Motion Sensor

Motion sensors are distributed in corridors and in a classroom section of the building where computer labs were once located. The intrusion system has limited programming and partitioning features, and has limited keypad functions for conveying information to users or the local Police.

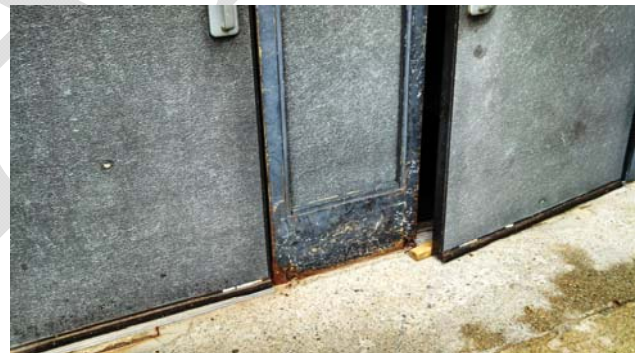
Door Propped Open

Exterior doors are numbered. Noted exterior doors propped open with no means of remote detection of the open condition.

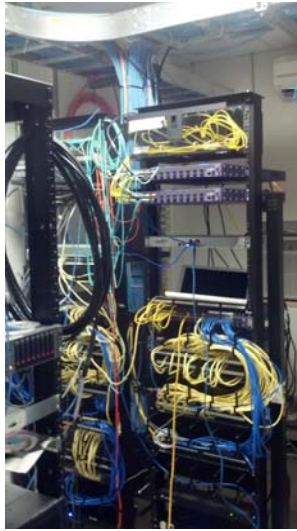
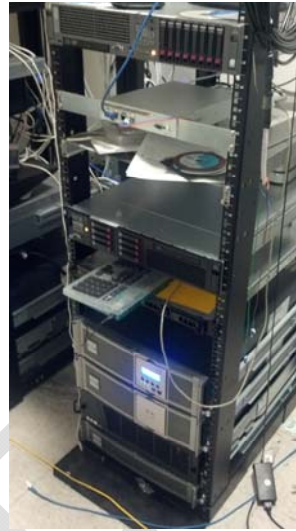
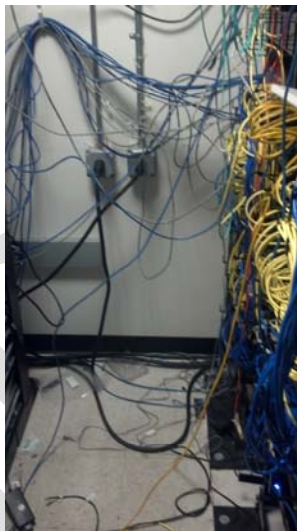
The MDF is the only communications equipment room with air conditioning. The unit is inadequate to maintain appropriate temperature and humidity levels for the current load. Lighting is adequate on the front of the equipment cabinets and poor on the back side. Electrical receptacles located behind the equipment racks are poorly located causing cable management problems. There is a total of five equipment racks in the room (four 4-post racks and two 2-post racks). Two racks have UPS back-up units with a total capacity of 10 KVa. One of the two UPS units is on the generator system. The other three racks are on standard power. Power services in the room will require that all service to network equipment be supplied from the emergency generator as well as upgrades to accommodate future equipment loads and to provide higher backup reliability in the event of power failure.

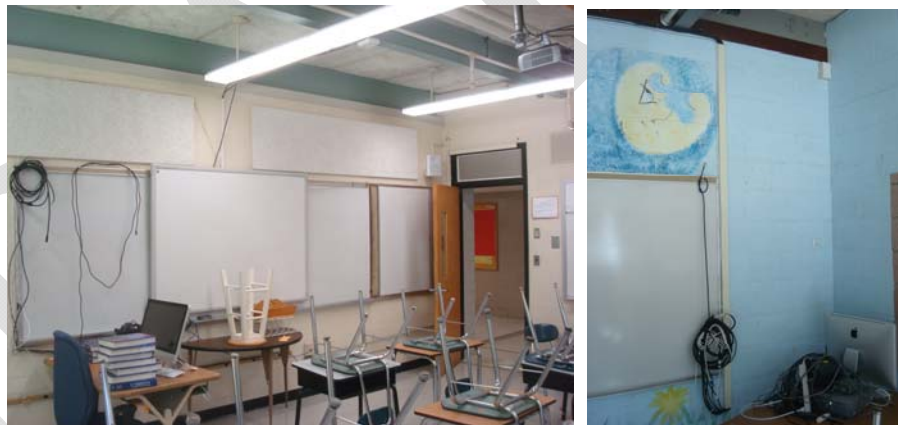
*Typical Classroom with Interactive White Board and Classroom with Coaxial Cable extended from Wall Outlet*

The typical Classroom is equipped with two data jacks. One is used by the Teacher. The second is used as the classroom telephone jack. The cable from this jack is patched onto the telephone backbone punch down blocks in each IDF and the MDF. Several classrooms have as many as four data jacks. Cable management in classrooms is poor.

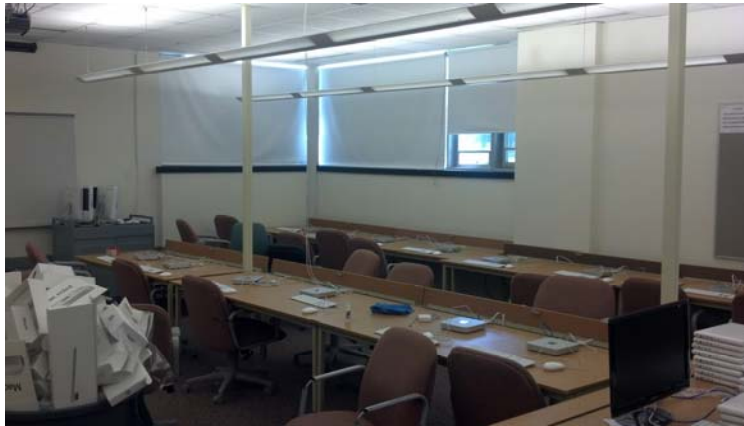
The Library has approximately 8 data outlets but needs at least 24 to support the equipment in the space. The Computer Lab in the Library also has 8 data outlets but needs at least 28. Offices are typically equipped with one or two data outlets. To compensate for the lack of data outlets, the IT Dept. has distributed small network switches in classrooms and other spaces where needed.

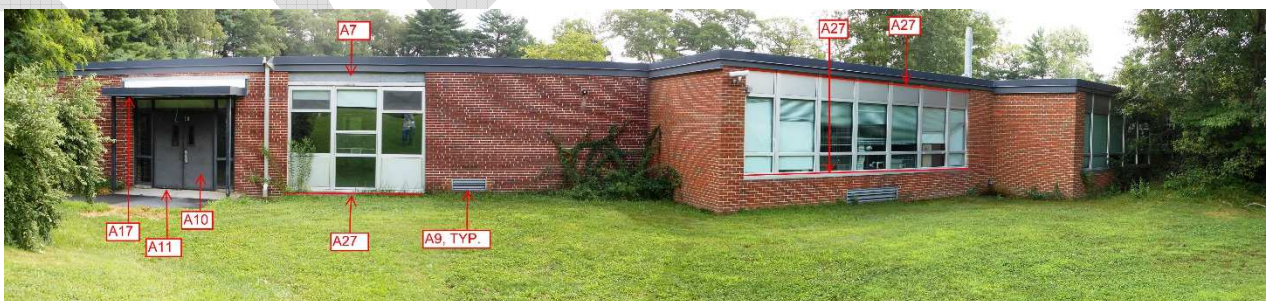
- Typical elevation showing work to be performed at classroom wings. Work includes replacing exterior doors, replacing door thresholds, replacing soffits, replacing abandoned light fixtures (where only housing and loose wiring remains), replacing sealant at louvers, power-washing entire facade, and brick repointing.
